General Information

Make	Toyota	Model	Vios
YOM	2021	Odo Meter Reading	28,820
Registration No.	NFI1438	Chassis No.	PA1B18F32M4153925
CC	1.3	Transmission	CVT
Fuel Type	Gas	Type of Body	Sedan
Colour	Blue

Body / Panel Condition

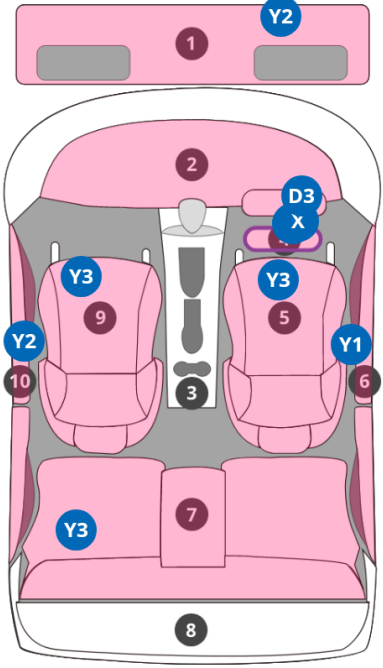
Interior Evaluation : C	Exterior Evaluation : E

<p>a : Cut, Fray d : Loose, Deformed k : Animal Hair s : Smell t : Cigarette Burns x : Defective y : Stain</p>

<p>A : Scratch AU : Scratch & Dent B : Modified C : Corrosion G : Stone chip P : Faded S : Rust SC : Rust & Corrosion U : Dent X : Defective Y : Crack, Gap</p>
<p>Remarks (L) Front Seat - Grime - Medium / (R) Front Seat - Grime - Medium / Rear Seat - Grime - Medium / (L) Front Floor Mat - Missing - Yes / (R) Front Floor Mat - Missing - Yes / (R) Front Trim - Grime - Minimal / Glove Box - Loose, Deformed - Medium / (L) Front Trim - Grime - Small / Ceiling - Grime - Small</p>	<p>Remarks (R) Front Fender, Molding - Scratch - Medium / (R) Mirror - Scratch - Minimal / (R) Front Door, Molding - Scratch - Small / (R) Rear Door, Molding - Scratch & Dent - Medium / (R) Rear Fender, Molding - Scratch & Dent - Large / Trunk Hood, Rear Gate - Scratch & Dent - Medium / Rear Bumper, Lamps, Panels - Scratch & Dent - Medium / (L) Rear Fender, Molding - Dent - Small / (L) Rear Door, Molding - Scratch - Minimal / (L) Front Door, Molding - Scratch & Dent - Minimal / (L) Mirror - Scratch - Minimal / Member (Bolted) - Dent - Yes / (L) Front Fender, Molding - Scratch - Small / Front Bumper, Grille, Lamps - Scratch - Medium / Bonnet, Headlight - Scratch - Minimal / Roof - Scratch - Small</p>

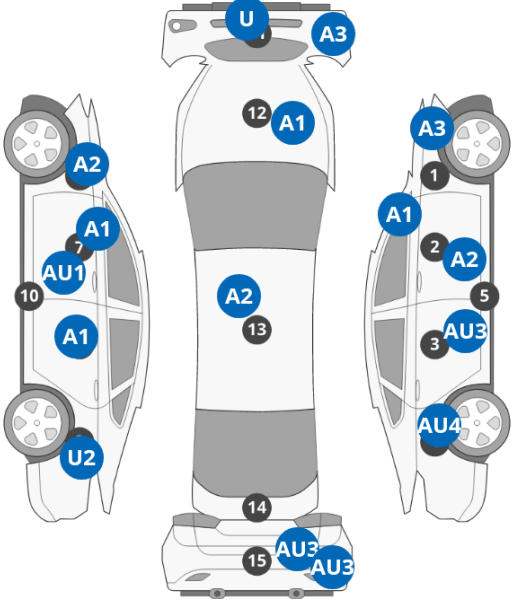
<p>Inspector Notes</p>
<p>with warranty booklet, no jack, incomplete tools, no spare tire, no LTO plate, no wiper blades, trunk cover missing, scratched and suncrack tail lights</p>
