## General Information

<b>Make</b>	Suzuki	<b>Model</b>	APV
<b>YOM</b>	2019	<b>Odo Meter Reading</b>	80,238
<b>Registration No.</b>	NEA9334	<b>Chassis No.</b>	MHYDN71T4KJ400494
<b>CC</b>	1.6	<b>Transmission</b>	M/T
<b>Fuel Type</b>	Gas	<b>Type of Body</b>	Van
<b>Colour</b>	White

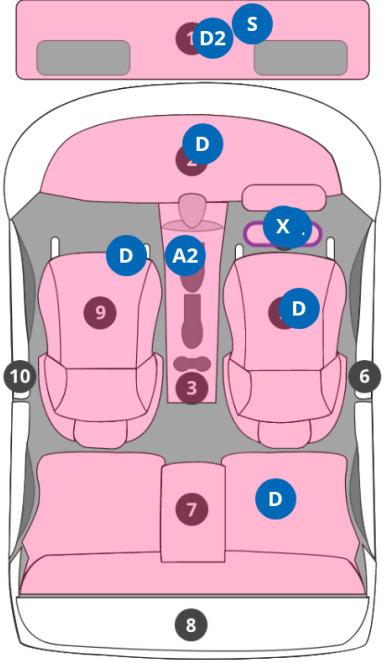
<b>Interior Evaluation :</b> <span style="float: right; color: red; font-weight: bold;">C</span>	<b>Exterior Evaluation :</b> <span style="float: right; color: red; font-weight: bold;">E</span>

<p><b>a</b> : Cut, Fray <b>d</b> : Loose, Deformed <b>k</b> : Animal Hair <b>s</b> : Smell <b>t</b> : Cigarette Burns <b>x</b> : Defective <b>y</b> : Stain</p>

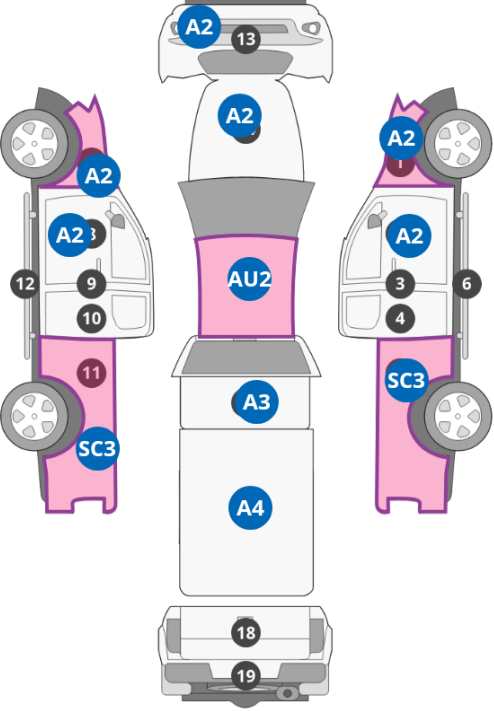
<p><b>A</b> : Scratch <b>AU</b> : Scratch &amp; Dent <b>B</b> : Modified <b>C</b> : Corrosion <b>G</b> : Stone chip <b>P</b> : Faded <b>S</b> : Rust <b>SC</b> : Rust &amp; Corrosion <b>U</b> : Dent <b>X</b> : Defective <b>Y</b> : Crack, Gap</p>
<p><b>Remarks</b> Overall Interior - Smell - Yes / Overall Interior - Worn as per age - Yes / (L) Front Floor Mat - Worked - Small / Mat Other - Missing - Yes / (R) Front Seat - Worn - Yes / (L) Front Seat - Worn - Yes / Rear Seat - Worn - Yes / Ceiling - Loose, Deformed - Small / Dashboard - Traces of Adhesive Tape - Yes / Console, Switches, Vents - Worn, Scratch, Cut, Crack - Small</p>	<p><b>Remarks</b> (L) Rear Corner Panel - Repair Traces - Yes / Roof - Repair Traces - Yes / (L) Side Gate - Repair mark - Yes / (R) Side Gate - Repair mark - Yes / Roof - Repair mark - Yes / (L) Front Fender, Molding - Repair mark - Yes / (R) Front Fender, Molding - Repair mark - Yes / (L) Side Gate - Rust, Corrosion - Medium / (L) Front Door, Molding - Scratch - Small / (L) Front Fender, Molding - Scratch - Small / Bonnet, Headlight - Scratch - Small / Front Bumper, Grille, Lamps - Scratch - Small / (R) Front Fender, Molding - Scratch - Small / (R) Front Door, Molding - Scratch - Small / (R) Side Gate - Rust, Corrosion - Medium / Roof - Scratch &amp; Dent - Small / Cargo Bed Floor - Scratch - Large / Cab Back Panel - Scratch - Medium</p>
