General Information

Make	Toyota	Model	Vios
YOM	2024	Odo Meter Reading	33,677
Registration No.	CCF2978	Chassis No.	PA1B18F30R4259670
CC	1.3	Transmission	CVT
Fuel Type	Gas	Type of Body	Sedan
Colour	Blackish Red Mica

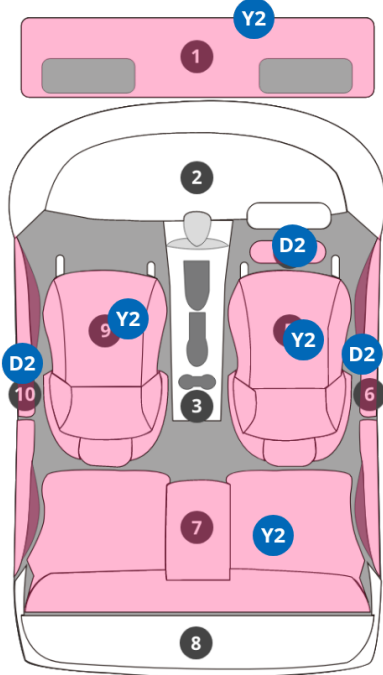
Interior Evaluation : B	Exterior Evaluation : E

<p>a : Cut, Fray d : Loose, Deformed k : Animal Hair s : Smell t : Cigarette Burns x : Defective y : Stain</p>

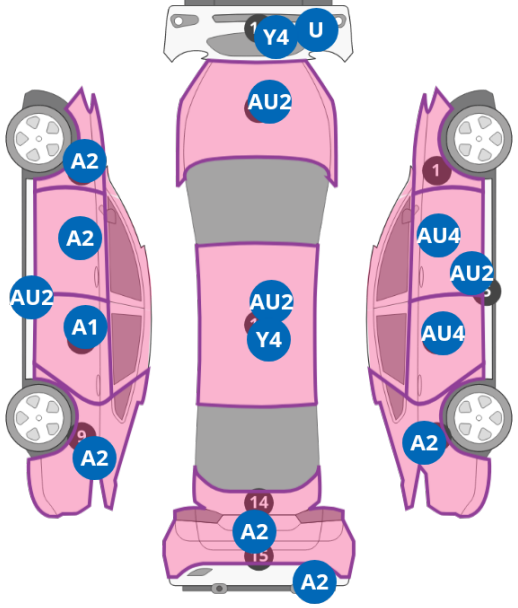
<p>A : Scratch AU : Scratch & Dent B : Modified C : Corrosion G : Stone chip P : Faded S : Rust SC : Rust & Corrosion U : Dent X : Defective Y : Crack, Gap</p>
<p>Remarks Ceiling - Grime - Small / (L) Front Floor Mat - Worked - Small / (R) Front Floor Mat - Worked - Small / (L) Front Trim - Worked - Small / (R) Front Trim - Worked - Small / Rear Seat - Grime - Small / (L) Front Seat - Grime - Small / (R) Front Seat - Grime - Small</p>	<p>Remarks (R) Front Door - Repair Traces - Yes / (R) Front Fender - Repair Traces - Yes / Bonnet - Repair Traces - Yes / (L) Front Fender - Repair Traces - Yes / (L) Front Door - Repair Traces - Yes / (L) Rear Door - Repair Traces - Yes / (L) Rear Fender - Repair Traces - Yes / Trunk Hood, Rear Gate - Repair Traces - Yes / (R) Rear Fender - Repair Traces - Yes / (R) Rear Door - Repair Traces - Yes / Roof - Repair Traces - Yes / Trunk Hood, Rear Gate - Repair mark - Yes / (L) Rear Fender, Molding - Repair mark - Yes / (L) Rear Door, Molding - Repair mark - Yes / (L) Front Door, Molding - Repair mark - Yes / (L) Front Fender, Molding - Repair mark - Yes / Bonnet, Headlight - Repair mark - Yes / (R) Front Fender, Molding - Repair mark - Yes / (R) Front Door, Molding - Repair mark - Yes / (R) Rear Door, Molding - Repair mark - Yes / (R) Rear Fender, Molding - Repair mark - Yes / Roof - Repair mark - Yes / Member (Bolted) - Dent - Yes / Front Bumper, Grille, Lamps - Crack, Gap - Large / (R) Front Door, Molding - Scratch & Dent - Large / (R) Rear Door, Molding - Scratch & Dent - Large / (R) Step, In-panel, Side Spoiler - Scratch & Dent - Small / (R) Rear Fender, Molding - Scratch - Small / Rear Bumper, Lamps, Panels - Scratch - Small / Trunk Hood, Rear Gate - Scratch - Small / (L) Rear Fender, Molding - Scratch - Small / (L) Rear Door, Molding - Scratch - Minimal / (L) Front Door, Molding - Scratch - Small / (L) Step, In-panel, Side Spoiler - Scratch & Dent - Small / (L) Front Fender, Molding - Scratch - Small / Bonnet, Headlight - Scratch & Dent - Small / Roof - Scratch & Dent - Small / Front Windshield - Damaged - Large</p>
