General Information

Make	Toyota	Model	Vios
YOM	2024	Odo Meter Reading	17,219
Registration No.	CAZ8349	Chassis No.	PA1B18F3XP4228715
CC	1.3	Transmission	CVT
Fuel Type	Gas	Type of Body	Sedan
Colour	Red Mica Metallic

Body / Panel Condition

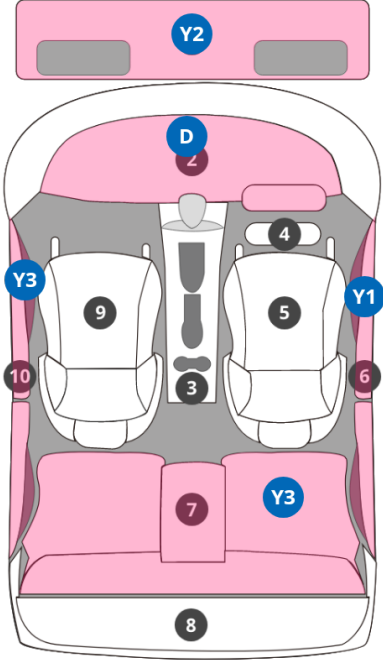
<p>a : Cut, Fray d : Loose, Deformed k : Animal Hair s : Smell t : Cigarette Burns x : Defective y : Stain</p>

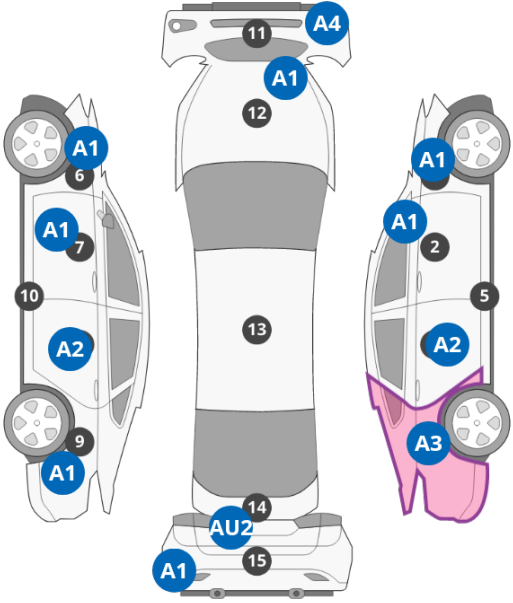
<p>A : Scratch AU : Scratch & Dent B : Modified C : Corrosion G : Stone chip P : Faded S : Rust SC : Rust & Corrosion U : Dent X : Defective Y : Crack, Gap</p>
<p>Remarks (R) Front Trim - Grime - Minimal / Rear Seat - Grime - Medium / (L) Front Trim - Grime - Medium / Dashboard - Traces of Adhesive Tape - Yes / Ceiling - Grime - Small</p>	<p>Remarks (R) Rear Fender - Repair Traces - Yes / (R) Rear Fender, Molding - Repair mark - Yes / (R) Mirror - Scratch - Minimal / Front Bumper, Grille, Lamps - Scratch - Large / Bonnet, Headlight - Scratch - Minimal / (L) Front Fender, Molding - Scratch - Minimal / (L) Rear Door, Molding - Scratch - Small / (L) Rear Fender, Molding - Scratch - Minimal / Trunk Hood, Rear Gate - Scratch & Dent - Small / Rear Bumper, Lamps, Panels - Scratch - Minimal / (R) Rear Fender, Molding - Scratch - Medium / (R) Rear Door, Molding - Scratch - Small / (R) Front Fender, Molding - Scratch - Minimal / (L) Front Door, Molding - Scratch - Minimal</p>
