General Information

Make	Mitsubishi	Model	Pajero
YOM	2012	Odo Meter Reading	79,256
Registration No.	UUI680	Chassis No.	JMYLYV97WCJ000178
CC	3.8	Transmission	A/T
Fuel Type	Gas	Type of Body	SUV
Colour	White

Body / Panel Condition

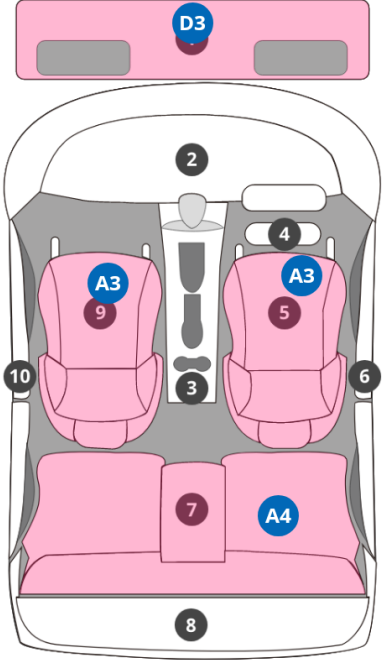
Interior Evaluation : C	Exterior Evaluation : C

<p>a : Cut, Fray d : Loose, Deformed k : Animal Hair s : Smell t : Cigarette Burns x : Defective y : Stain</p>

<p>A : Scratch AU : Scratch & Dent B : Modified C : Corrosion G : Stone chip P : Faded S : Rust SC : Rust & Corrosion U : Dent X : Defective Y : Crack, Gap</p>
<p>Remarks Overall Interior - Worn as per age - Yes / Ceiling - Crinkle - Medium / (R) Front Seat - Cut, Crack - Medium / (L) Front Seat - Cut, Crack - Medium / Rear Seat - Cut, Crack - Large</p>	<p>Remarks (R) Front Fender, Molding - Scratch - Minimal / (R) Mirror - Scratch - Minimal / (R) Step, In-panel, Side Spoiler - Scratch - Medium / (R) Front Door, Molding - Scratch - Minimal / (R) Rear Door, Molding - Dent - Minimal / (R) Rear Fender, Molding - Scratch - Minimal / Rear Bumper, Lamps, Panels - Scratch - Small / Trunk Hood, Rear Gate - Scratch - Small / (L) Rear Fender, Molding - Scratch - Small / (L) Rear Door, Molding - Scratch - Small / (L) Mirror - Scratch - Minimal / (L) Front Door, Molding - Scratch - Small / (L) Front Fender, Molding - Scratch - Minimal / Front Bumper, Grille, Lamps - Scratch - Small / Bonnet, Headlight - Scratch - Minimal / Roof - Dent - Minimal</p>

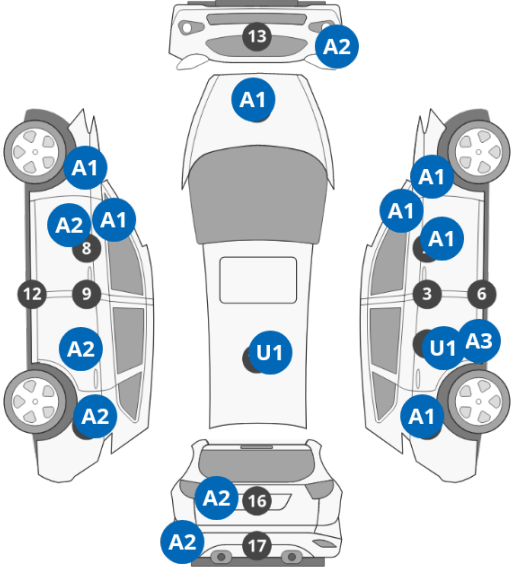
<p>Inspector Notes</p>
<p>with warranty booklet, with jack and tools, with spare tire, with LTO plate, scratches on tail light and headlight, suncrack tail light and headlight, brake lights issue,</p>
