General Information

Make	Toyota	Model	Vios
YOM	2021	Odo Meter Reading	34,395
Registration No.	NGS8974	Chassis No.	PA1B18F30M4134578
CC	1.3	Transmission	CVT
Fuel Type	Gas	Type of Body	Sedan
Colour	Blue

Body / Panel Condition

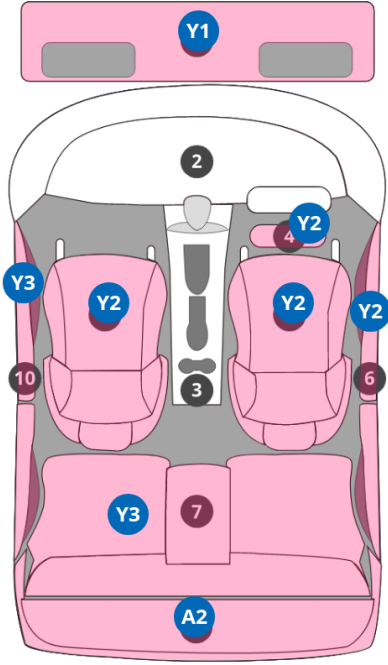
Interior Evaluation : C	Exterior Evaluation : E

<p>a : Cut, Fray d : Loose, Deformed k : Animal Hair s : Smell t : Cigarette Burns x : Defective y : Stain</p>

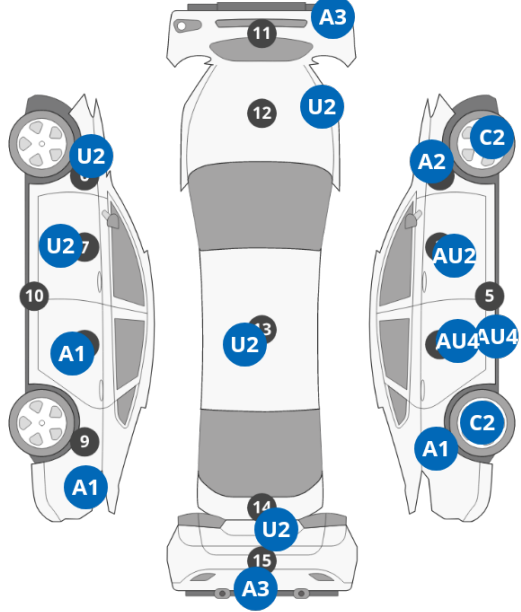
<p>A : Scratch AU : Scratch & Dent B : Modified C : Corrosion G : Stone chip P : Faded S : Rust SC : Rust & Corrosion U : Dent X : Defective Y : Crack, Gap</p>
<p>Remarks Rear Seat - Grime - Medium / Trunk Room - Worn, Scratch, Cut, Crack - Small / (L) Front Trim - Grime - Medium / (L) Front Seat - Grime - Small / (L) Front Floor Mat - Grime - Small / (R) Front Trim - Grime - Small / (R) Front Seat - Grime - Small / Ceiling - Grime - Minimal</p>	<p>Remarks Bonnet, Headlight - Dent - Small / Front Bumper, Grille, Lamps - Scratch - Medium / (L) Front Fender, Molding - Dent - Small / (L) Front Door, Molding - Dent - Small / Trunk Hood, Rear Gate - Dent - Small / Rear Bumper, Lamps, Panels - Scratch - Medium / (R) Rear Fender, Molding - Scratch - Minimal / (R) Step, In-panel, Side Spoiler - Scratch & Dent - Large / (R) Rear Door, Molding - Scratch & Dent - Large / (R) Front Door, Molding - Scratch & Dent - Small / (R) Front Fender, Molding - Scratch - Small / Roof - Dent - Small / (L) Rear Door, Molding - Scratch - Minimal / (L) Rear Fender, Molding - Scratch - Minimal / (R) Rear Wheel, Cover - Scratch, Corrosion - Small / (R) Front Wheel, Cover - Scratch, Corrosion - Small</p>
