General Information

Make	Toyota	Model	Vios
YOM	2021	Odo Meter Reading	33,870
Registration No.	NEW8956-1	Chassis No.	PA1B18F30M4144088
CC	1.3	Transmission	CVT
Fuel Type	Gas	Type of Body	Sedan
Colour	Red Mica Metallic

Body / Panel Condition

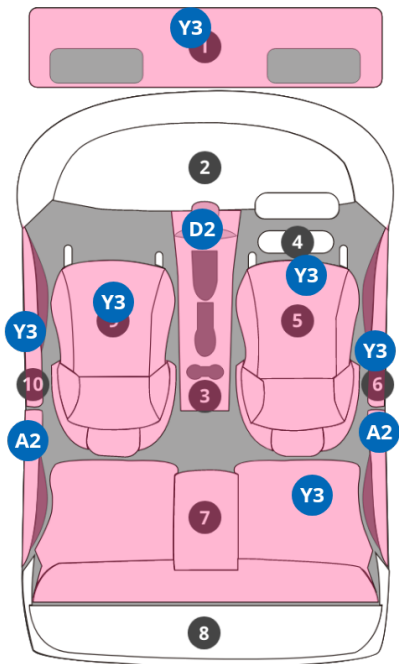
Interior Evaluation : C	Exterior Evaluation : C

<p>a : Cut, Fray d : Loose, Deformed k : Animal Hair s : Smell t : Cigarette Burns x : Defective y : Stain</p>

<p>A : Scratch AU : Scratch & Dent B : Modified C : Corrosion G : Stone chip P : Faded S : Rust SC : Rust & Corrosion U : Dent X : Defective Y : Crack, Gap</p>
<p>Remarks Console, Switches, Vents - Loose, Deformed - Small / (R) Front Seat - Grime - Medium / (L) Front Seat - Grime - Medium / Rear Seat - Grime - Medium / (R) Rear Trim - Cut, Crack - Small / Overall Interior - Worn as per age - Yes / (R) Front Trim - Grime - Medium / (L) Rear Trim - Cut, Crack - Small / (L) Front Trim - Grime - Medium / Ceiling - Grime - Medium</p>	<p>Remarks (R) Front Door - Repair Traces - Yes / (R) Front Fender - Repair Traces - Yes / Bonnet - Repair Traces - Yes / (L) Front Fender - Repair Traces - Yes / (L) Front Door - Repair Traces - Yes / (L) Rear Door - Repair Traces - Yes / (L) Rear Fender - Repair Traces - Yes / Trunk Hood, Rear Gate - Repair Traces - Yes / (R) Rear Fender - Repair Traces - Yes / (R) Rear Door - Repair Traces - Yes / Roof - Repair Traces - Yes / Overall Exterior - Full Re-Paint in same color - Yes / (R) Mirror - Faded(Color, Gloss) - Yes / (R) Front Fender, Molding - Scratch - Small / (R) Mirror - Scratch - Minimal / (R) Front Door, Molding - Scratch & Dent - Small / (R) Rear Fender, Molding - Scratch - Small / (R) Rear Door, Molding - Scratch - Minimal / Rear Bumper, Lamps, Panels - Repair mark - Yes / Rear Bumper, Lamps, Panels - Scratch & Dent - Medium / Trunk Hood, Rear Gate - Scratch & Dent - Minimal / (L) Rear Fender, Molding - Scratch - Minimal / (L) Rear Door, Molding - Scratch - Minimal / (L) Front Door, Molding - Scratch - Minimal / (L) Mirror - Scratch - Minimal / Member (Bolted) - Dent - Yes / (L) Front Fender, Molding - Repair mark - Yes / (L) Front Fender, Molding - Scratch - Minimal / Front Bumper, Grille, Lamps - Scratch - Small / Bonnet, Headlight - Crack, Gap - Large / Roof - Scratch & Dent - Minimal</p>

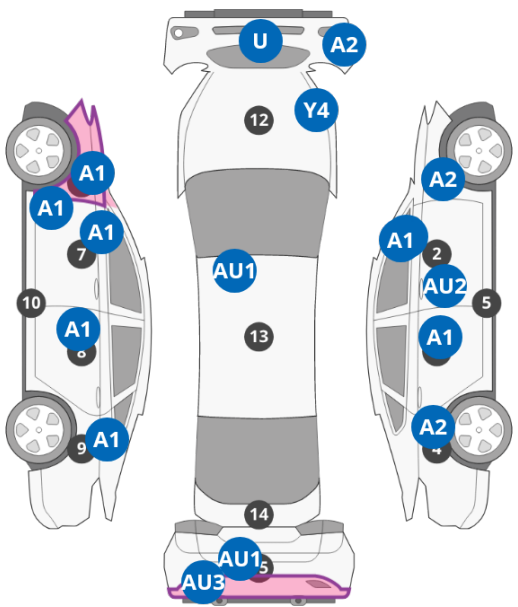
<p>Inspector Notes</p>
<p>no warranty booklet, with jack, incomplete tools, with spare tire, with LTO plate, scratches on tail light, possible flooding, uneven engine hood, trunk hood issue</p>
