General Information

Make	Toyota	Model	Vios
YOM	2018	Odo Meter Reading	67,646
Registration No.	NCW1041	Chassis No.	PA1B19F38J4064168
CC	1.3	Transmission	A/T
Fuel Type	Gas	Type of Body	Sedan
Colour	Orange

Body / Panel Condition

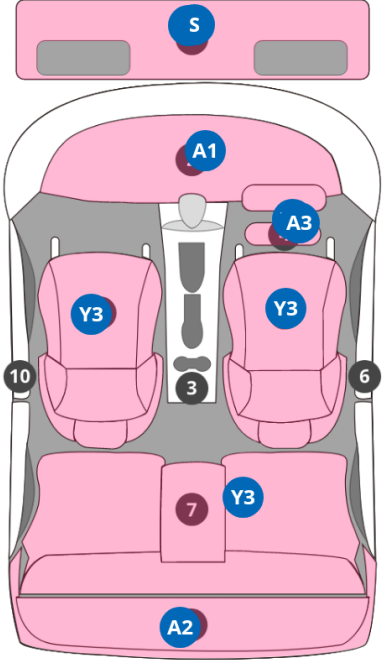
Interior Evaluation : C	Exterior Evaluation : D

<p>a : Cut, Fray d : Loose, Deformed k : Animal Hair s : Smell t : Cigarette Burns x : Defective y : Stain</p>

<p>A : Scratch AU : Scratch & Dent B : Modified C : Corrosion G : Stone chip P : Faded S : Rust SC : Rust & Corrosion U : Dent X : Defective Y : Crack, Gap</p>
<p>Remarks (R) Front Seat - Grime - Medium / (R) Front Floor Mat - Grime - Small / Rear Seat - Grime - Medium / Trunk Room - Worn, Scratch, Cut, Crack - Small / (L) Front Seat - Grime - Medium / (L) Front Floor Mat - Cut, Crack - Medium / Ceiling - Grime - Small / Dashboard - Worn, Scratch, Cut, Crack - Minimal / Overall Interior - Smell - Yes</p>	<p>Remarks (L) Rear Door - Repair Traces - Yes / (L) Rear Fender - Repair Traces - Yes / (L) Rear Fender, Molding - Repair mark - Yes / (L) Rear Door, Molding - Repair mark - Yes / Trunk Hood, Rear Gate - Dent - Minimal / Rear Bumper, Lamps, Panels - Scratch - Medium / (R) Rear Fender, Molding - Scratch & Dent - Small / (R) Rear Door, Molding - Scratch - Medium / (R) Front Door, Molding - Scratch & Dent - Small / (R) Mirror - Scratch - Minimal / (R) Front Fender, Molding - Dent - Minimal / Front Bumper, Grille, Lamps - Scratch - Large / (L) Front Door, Molding - Scratch - Minimal / (L) Rear Door, Molding - Scratch - Small / (L) Rear Fender, Molding - Scratch & Dent - Small / Bonnet, Headlight - Scratch - Small</p>
