General Information

Make	Toyota	Model	Vios
YOM	2023	Odo Meter Reading	98,497
Registration No.	DBJ7483	Chassis No.	PA1B18F3XP4225474
CC	1.3	Transmission	CVT
Fuel Type	Gas	Type of Body	Sedan
Colour	Red Mica Metallic

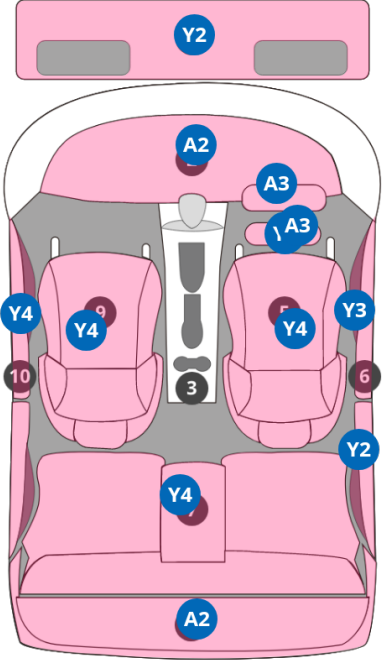
Interior Evaluation : E	Exterior Evaluation : E

<p>a : Cut, Fray d : Loose, Deformed k : Animal Hair s : Smell t : Cigarette Burns x : Defective y : Stain</p>

<p>A : Scratch AU : Scratch & Dent B : Modified C : Corrosion G : Stone chip P : Faded S : Rust SC : Rust & Corrosion U : Dent X : Defective Y : Crack, Gap</p>
<p>Remarks Rear Seat - Grime - Large / Mat Other - Grime - Medium / (R) Front Trim - Grime - Medium / (R) Front Seat - Grime - Large / (R) Front Floor Mat - Grime - Small / (R) Rear Trim - Grime - Small / (L) Front Trim - Grime - Large / (L) Front Seat - Grime - Large / Steering Wheel - Worn, Peel, Crack - Medium / (L) Front Floor Mat - Cut, Crack - Medium / Dashboard - Worn, Scratch, Cut, Crack - Small / Ceiling - Grime - Small / Trunk Room - Worn, Scratch, Cut, Crack - Small</p>	<p>Remarks Rear Bumper, Lamps, Panels - Scratch - Medium / Trunk Hood, Rear Gate - Dent - Small / (R) Rear Fender, Molding - Scratch & Dent - Small / (R) Rear Door, Molding - Scratch - Medium / (R) Front Door, Molding - Scratch - Medium / (R) Front Fender, Molding - Scratch - Small / (R) Mirror - Scratch - Minimal / Front Bumper, Grille, Lamps - Crack, Gap - Large / (L) Front Fender, Molding - Scratch & Dent - Medium / (L) Front Door, Molding - Scratch & Dent - Medium / (L) Rear Door, Molding - Scratch - Small / (L) Rear Fender, Molding - Scratch - Small / Roof - Dent - Small</p>
