General Information

Make	Toyota	Model	Vios
YOM	2024	Odo Meter Reading	46,875
Registration No.	DBN5772	Chassis No.	PA1B18F39P4232609
CC	1.3	Transmission	CVT
Fuel Type	Gas	Type of Body	Sedan
Colour	Silver

Body / Panel Condition

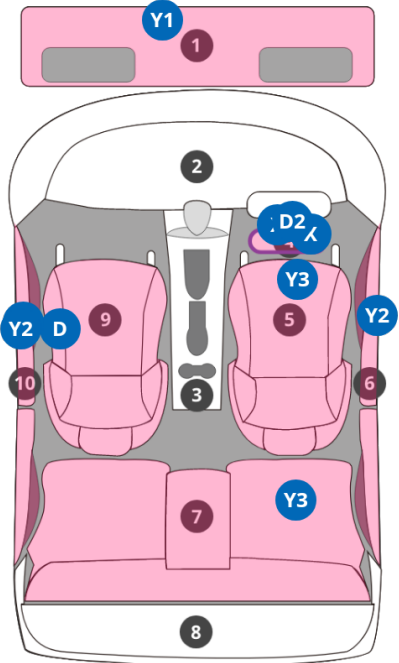
Interior Evaluation : C	Exterior Evaluation : E

<p>a : Cut, Fray d : Loose, Deformed k : Animal Hair s : Smell t : Cigarette Burns x : Defective y : Stain</p>

<p>A : Scratch AU : Scratch & Dent B : Modified C : Corrosion G : Stone chip P : Faded S : Rust SC : Rust & Corrosion U : Dent X : Defective Y : Crack, Gap</p>
<p>Remarks (R) Front Seat - Grime - Medium / (L) Front Seat - Worn - Yes / Rear Seat - Grime - Medium / Mat Other - Missing - Yes / (R) Front Trim - Grime - Small / (R) Front Floor Mat - Missing - Yes / (L) Front Floor Mat - Worked - Small / (L) Front Trim - Worked - Small / (L) Front Trim - Grime - Small / Ceiling - Grime - Minimal</p>	<p>Remarks (R) Front Fender - Repair Traces - Yes / (R) Rear Fender - Repair Traces - Yes / (R) Rear Door - Repair Traces - Yes / (R) Front Fender, Molding - Dent - Minimal / (R) Mirror - Faded(Color, Gloss) - Yes / (R) Mirror - Scratch - Minimal / (R) Step, In-panel, Side Spoiler - Scratch & Dent - Medium / (R) Front Door, Molding - Scratch - Medium / (R) Rear Door, Molding - Scratch - Small / (R) Rear Fender, Molding - Scratch - Minimal / Rear Bumper, Lamps, Panels - Scratch - Small / Trunk Hood, Rear Gate - Scratch - Small / (L) Rear Fender, Molding - Scratch - Small / (L) Rear Door, Molding - Scratch - Small / (L) Step, In-panel, Side Spoiler - Scratch & Dent - Medium / (L) Front Door, Molding - Scratch & Dent - Medium / (L) Mirror - Scratch - Small / Member (Bolted) - Dent - Yes / (L) Front Fender, Molding - Scratch - Minimal / Front Bumper, Grille, Lamps - Scratch & Dent - Small / Bonnet, Headlight - Dent - Small / Roof - Scratch - Minimal</p>

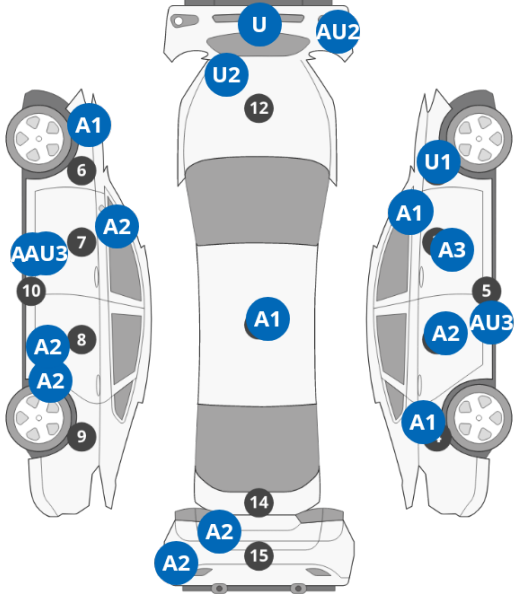
<p>Inspector Notes</p>
<p>with warranty booklet, no jack, incomplete tools, no spare tire, with LTO plate, scratches on tail light, deformed trunk floorbed cover</p>
