General Information

| Make | Toyota | Model | Vios |
| Registration No. | NHM1698 | Chassis No. | PA1B18F3XP4235986 |

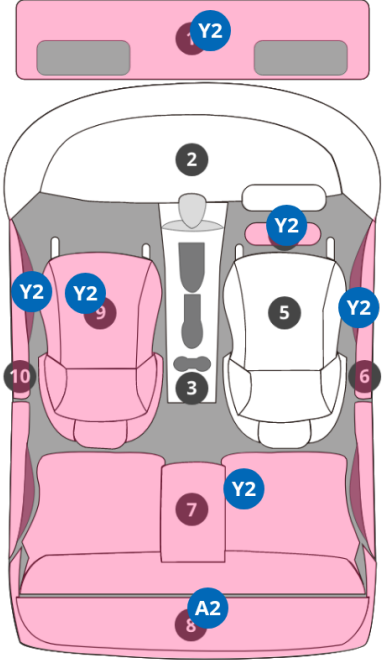
| Interior Evaluation : B | Exterior Evaluation : B |
| <p>Remarks Rear Seat - Grime - Small / (R) Front Trim - Grime - Small / Trunk Room - Worn, Scratch, Cut, Crack - Small / (L) Front Floor Mat - Grime - Small / (L) Front Seat - Grime - Small / (L) Front Trim - Grime - Small / Ceiling - Grime - Small</p> | <p>Remarks (R) Rear Fender, Molding - Scratch - Small / Front Bumper, Grille, Lamps - Scratch - Small / (L) Front Fender, Molding - Scratch & Dent - Small / (L) Rear Door, Molding - Scratch - Small / Rear Bumper, Lamps, Panels - Scratch - Small / Roof - Scratch - Small / Bonnet, Headlight - Scratch - Small</p> |
