General Information

Make	Toyota	Model	Vios
YOM	2024	Odo Meter Reading	120,707
Registration No.	NHN2845	Chassis No.	PA1B18F36P4236570
CC	1.3	Transmission	CVT
Fuel Type	Gas	Type of Body	Sedan
Colour	Red Mica Metallic

Body / Panel Condition

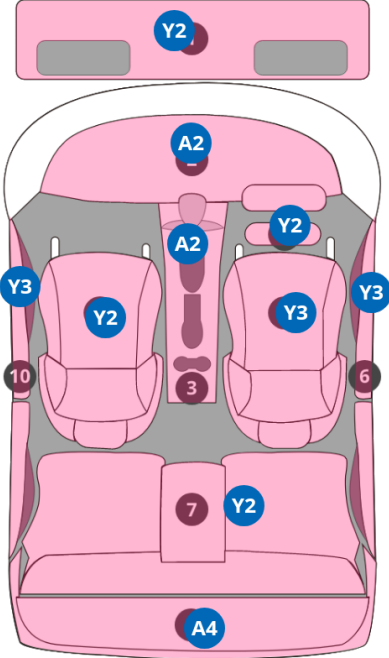
Interior Evaluation : C	Exterior Evaluation : E

<p>a : Cut, Fray d : Loose, Deformed k : Animal Hair s : Smell t : Cigarette Burns x : Defective y : Stain</p>

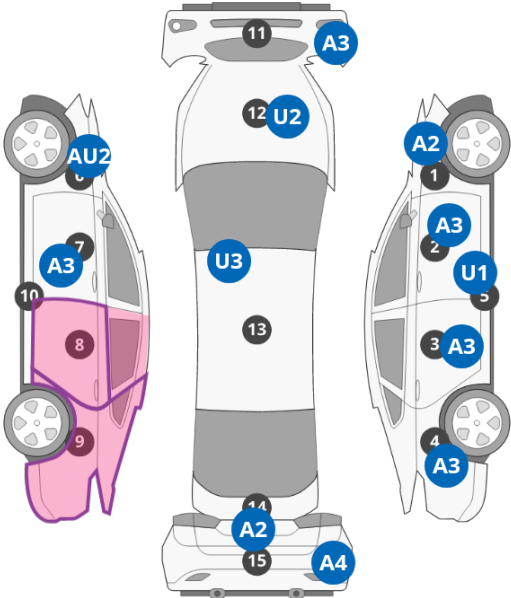
<p>A : Scratch AU : Scratch & Dent B : Modified C : Corrosion G : Stone chip P : Faded S : Rust SC : Rust & Corrosion U : Dent X : Defective Y : Crack, Gap</p>
<p>Remarks Trunk Room - Worn, Scratch, Cut, Crack - Large / Rear Seat - Grime - Small / (R) Front Seat - Grime - Medium / (R) Front Trim - Grime - Medium / (L) Front Trim - Grime - Medium / (L) Front Seat - Grime - Small / (L) Front Floor Mat - Grime - Small / Console, Switchs, Vents - Worn, Scratch, Cut, Crack - Small / Dashboard - Worn, Scratch, Cut, Crack - Small / Ceiling - Grime - Small</p>	<p>Remarks (R) Front Fender - Repair Traces - Yes / (L) Front Fender - Repair Traces - Yes / (L) Front Door - Repair Traces - Yes / (L) Rear Door - Repair Traces - Yes / (L) Rear Fender - Repair Traces - Yes / (R) Rear Fender - Repair Traces - Yes / (R) Rear Door - Repair Traces - Yes / Roof - Repair Traces - Yes / (L) Rear Fender, Molding - Repair mark - Difference in Color / (L) Rear Door, Molding - Repair mark - Difference in Color / (L) Front Fender, Molding - Scratch & Dent - Small / Front Bumper, Grille, Lamps - Scratch - Medium / (R) Front Fender, Molding - Scratch - Small / (R) Front Door, Molding - Scratch - Medium / (R) Step, In-panel, Side Spoiler - Dent - Minimal / (R) Rear Door, Molding - Scratch - Medium / (R) Rear Fender, Molding - Scratch - Medium / Rear Bumper, Lamps, Panels - Scratch - Large / Trunk Hood, Rear Gate - Scratch - Small / Roof - Dent - Medium / (L) Front Door, Molding - Scratch - Medium / Bonnet, Headlight - Dent - Small</p>
