General Information

Make	Suzuki	Model	S-Presso
YOM	2024	Odo Meter Reading	7,710
Registration No.	NHQ7295	Chassis No.	MA3FL61S1RA471230
CC	1.0	Transmission	A/T
Fuel Type	Gas	Type of Body	Hatchback
Colour	Gray

Body / Panel Condition

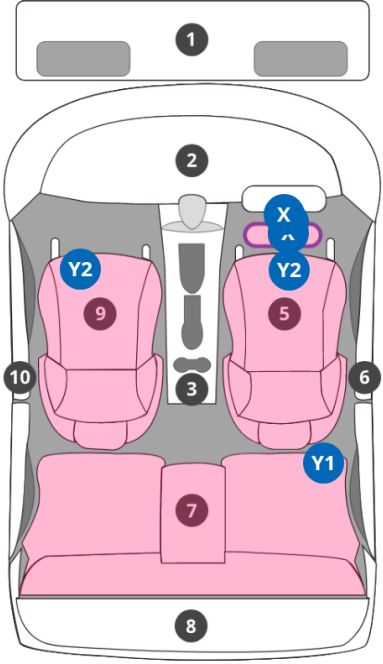
Interior Evaluation : B	Exterior Evaluation : C

<p>a : Cut, Fray d : Loose, Deformed k : Animal Hair s : Smell t : Cigarette Burns x : Defective y : Stain</p>

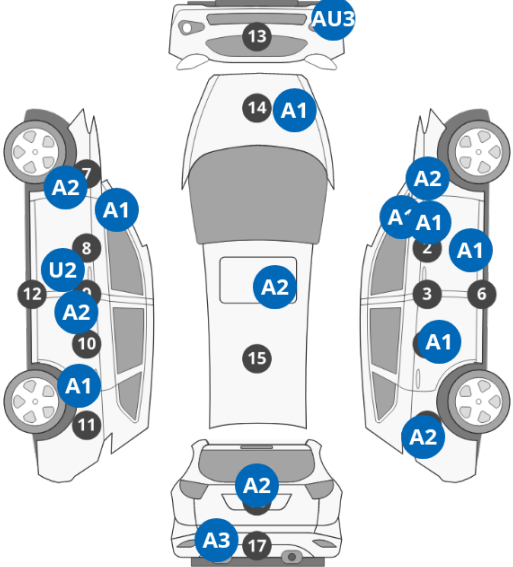
<p>A : Scratch AU : Scratch & Dent B : Modified C : Corrosion G : Stone chip P : Faded S : Rust SC : Rust & Corrosion U : Dent X : Defective Y : Crack, Gap</p>
<p>Remarks Mat Other - Missing - Yes / (L) Front Floor Mat - Missing - Yes / (R) Front Floor Mat - Missing - Yes / (R) Front Seat - Grime - Small / (L) Front Seat - Grime - Small / Rear Seat - Grime - Minimal</p>	<p>Remarks (R) Front Fender, Molding - Scratch - Small / (R) Mirror - Scratch - Minimal / (R) Front Door, Molding - Scratch - Minimal / (R) Step, In-panel, Side Spoiler - Scratch - Minimal / (R) Rear Door, Molding - Scratch - Minimal / (R) Rear Fender, Molding - Scratch - Small / Rear Bumper, Lamps, Panels - Scratch - Medium / Trunk Hood, Rear Gate - Scratch - Small / (L) Rear Fender, Molding - Scratch - Minimal / (L) Rear Door, Molding - Scratch - Small / (L) Front Door, Molding - Dent - Small / (L) Mirror - Scratch - Minimal / (L) Front Fender, Molding - Scratch - Small / Front Bumper, Grille, Lamps - Scratch & Dent - Medium / Bonnet, Headlight - Scratch - Minimal / Roof - Scratch - Small</p>

<p>Inspector Notes</p>
<p>no warranty booklet, no jack, with tools, no spare tire, with LTO plate, scratches on tail light</p>
