General Information

Make	Toyota	Model	Vios
YOM	2023	Odo Meter Reading	79,531
Registration No.	NIN6302	Chassis No.	PA1B18F34P4209447
CC	1.3	Transmission	CVT
Fuel Type	Gas	Type of Body	Sedan
Colour	Black

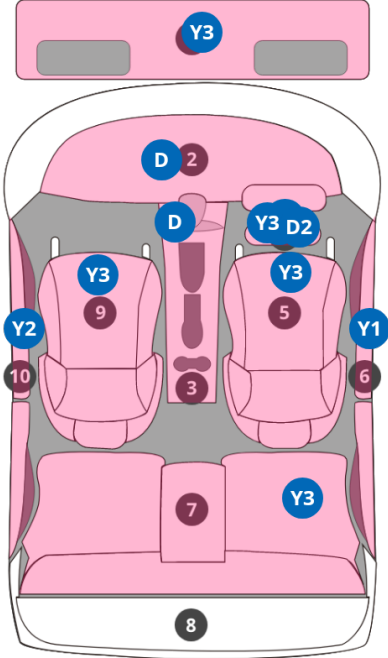
Interior Evaluation : D	Exterior Evaluation : E

<p>a : Cut, Fray d : Loose, Deformed k : Animal Hair s : Smell t : Cigarette Burns x : Defective y : Stain</p>

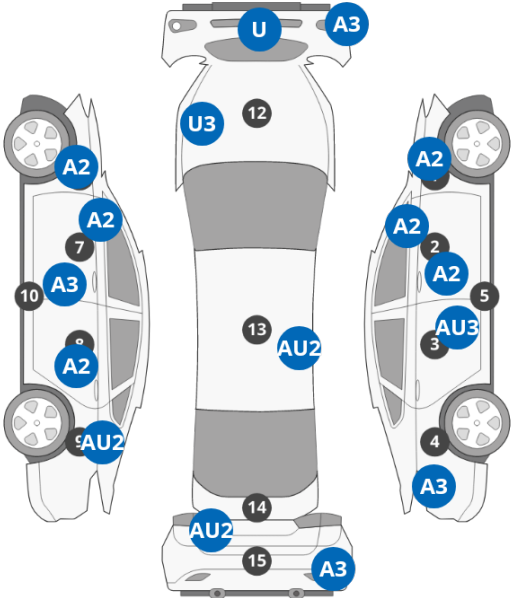
<p>A : Scratch AU : Scratch & Dent B : Modified C : Corrosion G : Stone chip P : Faded S : Rust SC : Rust & Corrosion U : Dent X : Defective Y : Crack, Gap</p>
<p>Remarks Mat Other - Grime - Large / (R) Front Seat - Grime - Medium / (L) Front Seat - Grime - Medium / Rear Seat - Grime - Medium / (R) Front Trim - Grime - Minimal / (R) Front Floor Mat - Worked - Small / (L) Front Floor Mat - Grime - Medium / (L) Front Trim - Grime - Small / Ceiling - Grime - Medium / Console, Switches, Vents - Traces of Adhesive Tape - Yes / Dashboard - Traces of Adhesive Tape - Yes / (L) Front Floor Mat - Worked - Small</p>	<p>Remarks (R) Front Fender, Molding - Scratch - Small / (R) Mirror - Scratch - Small / (R) Rear Door, Molding - Scratch & Dent - Medium / (R) Front Door, Molding - Scratch - Small / (R) Rear Fender, Molding - Scratch - Medium / Rear Bumper, Lamps, Panels - Scratch - Medium / Trunk Hood, Rear Gate - Scratch & Dent - Small / (L) Rear Fender, Molding - Scratch & Dent - Small / (L) Rear Door, Molding - Scratch - Small / (L) Front Door, Molding - Scratch - Medium / (L) Mirror - Scratch - Small / (L) Front Fender, Molding - Scratch - Small / Member (Bolted) - Dent - Yes / Front Bumper, Grille, Lamps - Scratch - Medium / Bonnet, Headlight - Dent - Medium / Roof - Scratch & Dent - Small</p>
