General Information

Make	Toyota	Model	Vios
YOM	2024	Odo Meter Reading	45,920
Registration No.	NIR8844	Chassis No.	PA1B18F32P4226800
CC	1.3	Transmission	CVT
Fuel Type	Gas	Type of Body	Sedan
Colour	Blue

Body / Panel Condition

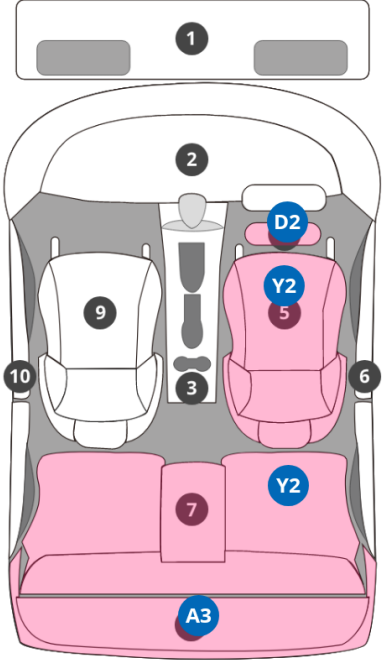
Interior Evaluation : B	Exterior Evaluation : D

<p>a : Cut, Fray d : Loose, Deformed k : Animal Hair s : Smell t : Cigarette Burns x : Defective y : Stain</p>

<p>A : Scratch AU : Scratch & Dent B : Modified C : Corrosion G : Stone chip P : Faded S : Rust SC : Rust & Corrosion U : Dent X : Defective Y : Crack, Gap</p>
<p>Remarks Trunk Room - Worn, Scratch, Cut, Crack - Medium / Rear Seat - Grime - Small / (R) Front Seat - Grime - Small / (L) Front Floor Mat - Worked - Small</p>	<p>Remarks (R) Front Fender, Molding - Scratch - Small / (R) Mirror - Scratch - Minimal / (R) Front Door, Molding - Scratch - Medium / (R) Rear Door, Molding - Scratch - Minimal / (R) Rear Fender, Molding - Scratch - Medium / Rear Bumper, Lamps, Panels - Scratch - Large / (L) Rear Fender, Molding - Scratch - Medium / (L) Rear Door, Molding - Scratch - Minimal / (L) Front Door, Molding - Scratch - Minimal / (L) Front Fender, Molding - Scratch - Minimal / Roof - Scratch - Minimal / Front Bumper, Grille, Lamps - Scratch - Large / Bonnet, Headlight - Scratch - Minimal / Trunk Hood, Rear Gate - Scratch - Small</p>
