## General Information

<b>Make</b>	Toyota	<b>Model</b>	Vios
<b>YOM</b>	2025	<b>Odo Meter Reading</b>	9,037
<b>Registration No.</b>	NJA2805	<b>Chassis No.</b>	PA1B18F39S4281737
<b>CC</b>	1.3	<b>Transmission</b>	CVT
<b>Fuel Type</b>	Gas	<b>Type of Body</b>	Sedan
<b>Colour</b>	Blue

## Body / Panel Condition

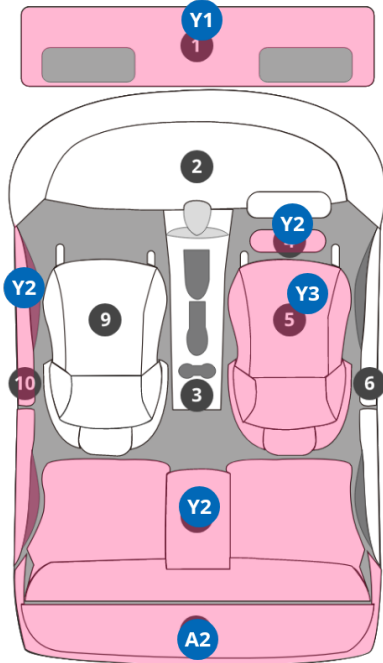
<b>Interior Evaluation :</b> <span style="float: right; color: red; font-weight: bold;">B</span>	<b>Exterior Evaluation :</b> <span style="float: right; color: red; font-weight: bold;">C</span>

<p><b>a</b> : Cut, Fray <b>d</b> : Loose, Deformed <b>k</b> : Animal Hair <b>s</b> : Smell <b>t</b> : Cigarette Burns <b>x</b> : Defective <b>y</b> : Stain</p>

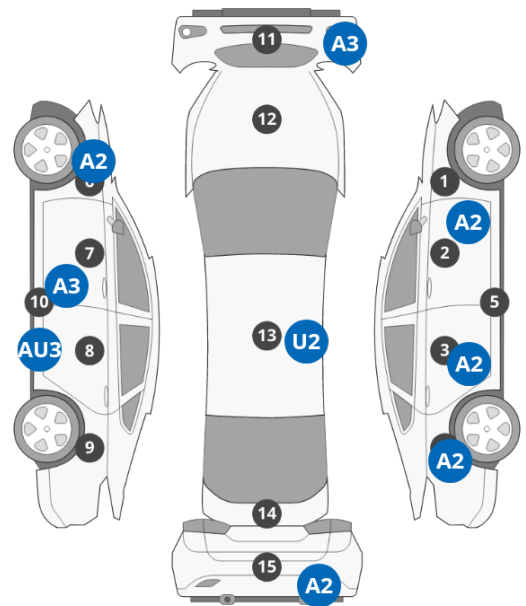
<p><b>A</b> : Scratch <b>AU</b> : Scratch &amp; Dent <b>B</b> : Modified <b>C</b> : Corrosion <b>G</b> : Stone chip <b>P</b> : Faded <b>S</b> : Rust <b>SC</b> : Rust &amp; Corrosion <b>U</b> : Dent <b>X</b> : Defective <b>Y</b> : Crack, Gap</p>
<p><b>Remarks</b> Trunk Room - Worn, Scratch, Cut, Crack - Small / Rear Seat - Grime - Small / (R) Front Seat - Grime - Medium / (L) Front Trim - Grime - Small / (L) Front Floor Mat - Grime - Small / Ceiling - Grime - Minimal</p>	<p><b>Remarks</b> (R) Front Door - Repair Traces - Yes / (L) Front Fender, Molding - Scratch - Small / (L) Front Door, Molding - Scratch - Medium / (L) Step, In-panel, Side Spoiler - Scratch &amp; Dent - Medium / Rear Bumper, Lamps, Panels - Scratch - Small / (R) Rear Fender, Molding - Scratch - Small / (R) Rear Door, Molding - Scratch - Small / (R) Front Door, Molding - Scratch - Small / Front Bumper, Grille, Lamps - Scratch - Medium / Roof - Dent - Small</p>

<p><b>Inspector Notes</b></p>
<p>with LTO plate/with spare tire/with spare key/No jack and tools/No warranty booklet/with reverse camera/Left side tail light cover small crack/trunk room carpet missing</p>
