General Information

Make	Toyota	Model	Vios
YOM	2024	Odo Meter Reading	29,625
Registration No.	NKD8963	Chassis No.	PA1B18F38R4252627
CC	1.3	Transmission	CVT
Fuel Type	Gas	Type of Body	Sedan
Colour	Red Mica Metallic

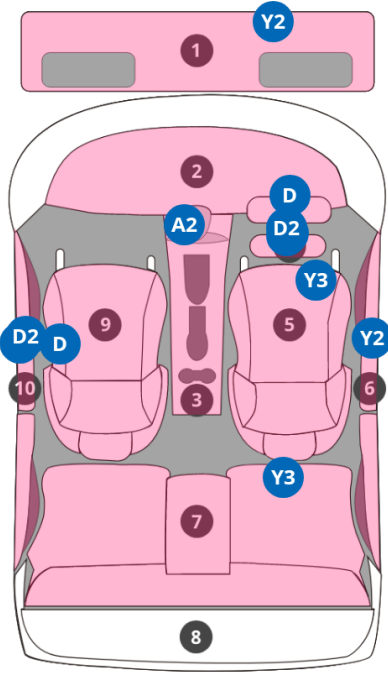
Interior Evaluation : C	Exterior Evaluation : D

<p>a : Cut, Fray d : Loose, Deformed k : Animal Hair s : Smell t : Cigarette Burns x : Defective y : Stain</p>

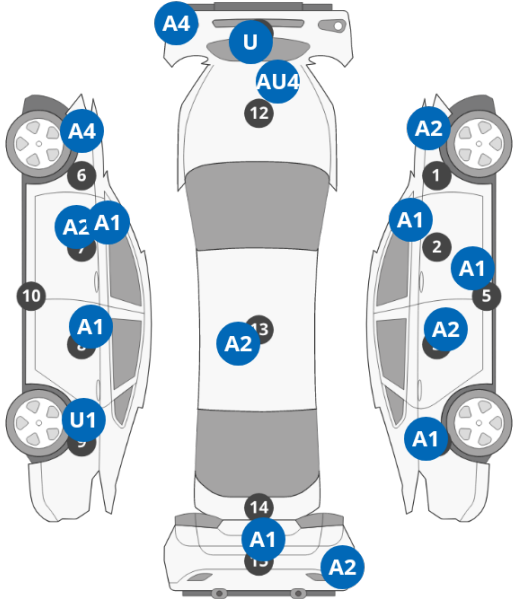
<p>A : Scratch AU : Scratch & Dent B : Modified C : Corrosion G : Stone chip P : Faded S : Rust SC : Rust & Corrosion U : Dent X : Defective Y : Crack, Gap</p>
<p>Remarks (R) Front Seat - Grime - Medium / (L) Front Seat - Worn - Yes / Rear Seat - Grime - Medium / (R) Front Trim - Grime - Small / (L) Front Trim - Grime - Small / (L) Front Trim - Worked - Small / (L) Front Floor Mat - Worked - Small / (L) Front Floor Mat - Cut, Crack - Small / (R) Front Floor Mat - Worked - Small / Console, Switches, Vents - Worn, Scratch, Cut, Crack - Small / Dashboard - Traces of Adhesive Tape - Yes / Ceiling - Grime - Small</p>	<p>Remarks (R) Front Fender, Molding - Scratch - Small / (R) Mirror - Scratch - Minimal / (R) Front Door, Molding - Scratch - Minimal / (R) Rear Door, Molding - Scratch - Small / (R) Rear Fender, Molding - Scratch - Minimal / Rear Bumper, Lamps, Panels - Scratch - Small / Trunk Hood, Rear Gate - Scratch - Minimal / (L) Rear Fender, Molding - Dent - Minimal / (L) Rear Door, Molding - Scratch - Minimal / (L) Front Door, Molding - Scratch - Small / (L) Mirror - Scratch - Minimal / (L) Front Fender, Molding - Scratch - Large / Member (Bolted) - Dent - Yes / Front Bumper, Grille, Lamps - Scratch - Large / Bonnet, Headlight - Scratch & Dent - Large / Roof - Scratch - Small</p>
