General Information

Make	Toyota	Model	Vios
YOM	2022	Odo Meter Reading	63,866
Registration No.	DAP9904	Chassis No.	PA1B18F32N4173173
CC	1.3	Transmission	CVT
Fuel Type	Gas	Type of Body	Sedan
Colour	Black

Body / Panel Condition

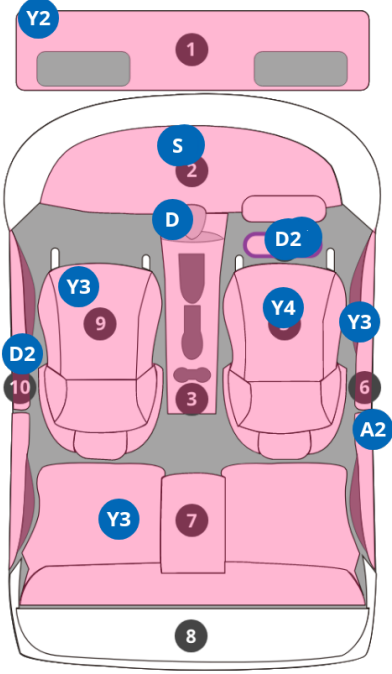
Interior Evaluation : C	Exterior Evaluation : E

<p>a : Cut, Fray d : Loose, Deformed k : Animal Hair s : Smell t : Cigarette Burns x : Defective y : Stain</p>

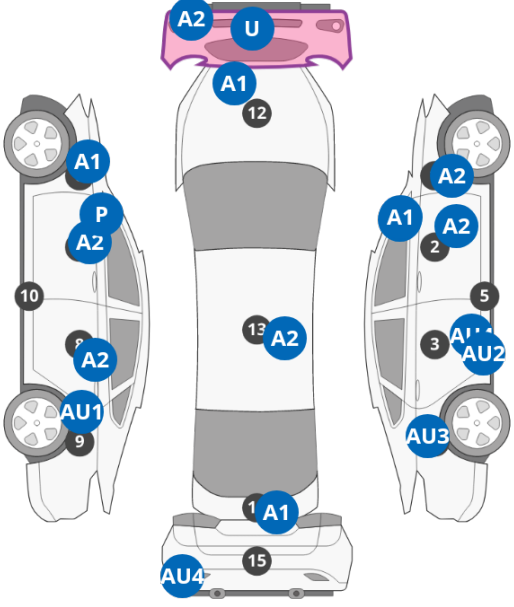
<p>A : Scratch AU : Scratch & Dent B : Modified C : Corrosion G : Stone chip P : Faded S : Rust SC : Rust & Corrosion U : Dent X : Defective Y : Crack, Gap</p>
<p>Remarks (R) Front Seat - Grime - Large / (L) Front Seat - Grime - Medium / Rear Seat - Grime - Medium / (R) Front Floor Mat - Missing - Yes / (R) Rear Trim - Cut, Crack - Small / (R) Front Trim - Grime - Medium / Overall Interior - Animal Hair - Yes / (L) Front Floor Mat - Worked - Small / (L) Front Trim - Worked - Small / Ceiling - Grime - Small / Console, Switches, Vents - Traces of Adhesive Tape - Yes / Dashboard - Traces of Adhesive Tape - Yes / Overall Interior - Smell - Yes</p>	<p>Remarks (R) Front Fender - Repair Traces - Yes / (L) Front Fender - Repair Traces - Yes / (R) Mirror - Crack - Damaged / (R) Mirror - Scratch - Minimal / (R) Front Fender, Molding - Scratch - Small / (R) Rear Door, Molding - Scratch & Dent - Large / (R) Front Door, Molding - Scratch - Small / (R) Step, In-panel, Side Spoiler - Scratch & Dent - Small / (R) Rear Fender, Molding - Scratch & Dent - Medium / Rear Bumper, Lamps, Panels - Scratch & Dent - Large / Trunk Hood, Rear Gate - Scratch - Minimal / (L) Rear Fender, Molding - Scratch & Dent - Minimal / (L) Rear Door, Molding - Scratch - Small / (L) Front Door, Molding - Scratch - Small / (L) Mirror - Faded(Color, Gloss) - Yes / (L) Front Fender, Molding - Scratch - Minimal / Member (Bolted) - Dent - Yes / Front Bumper, Grille, Lamps - Repair mark - Yes / Front Bumper, Grille, Lamps - Scratch - Small / Bonnet, Headlight - Scratch - Minimal / Roof - Scratch - Small</p>
