General Information

Make	Toyota	Model	Innova
YOM	2024	Odo Meter Reading	125,198
Registration No.	DBO9652	Chassis No.	PA2JA8EM2R0143315
CC	2.8	Transmission	A/T
Fuel Type	Diesel	Type of Body	Wagon
Colour	Red Mica Metallic

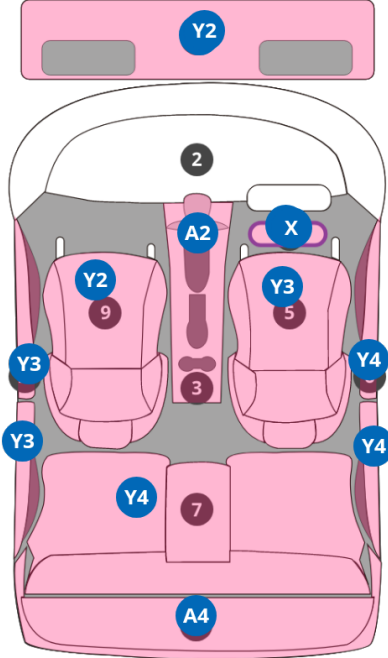
Interior Evaluation : E	Exterior Evaluation : D

<p>a : Cut, Fray d : Loose, Deformed k : Animal Hair s : Smell t : Cigarette Burns x : Defective y : Stain</p>

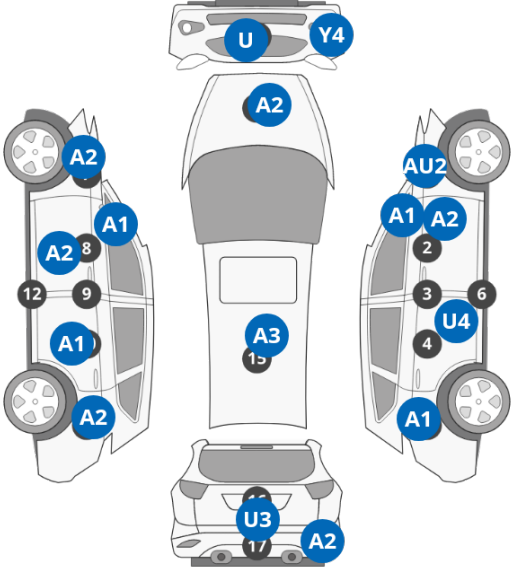
<p>A : Scratch AU : Scratch & Dent B : Modified C : Corrosion G : Stone chip P : Faded S : Rust SC : Rust & Corrosion U : Dent X : Defective Y : Crack, Gap</p>
<p>Remarks Trunk Room - Worn, Scratch, Cut, Crack - Large / Rear Seat - Grime - Large / (L) Rear Trim - Grime - Medium / Overall Interior - Worn as per age - Yes / Overall Interior - Smell - Yes / (L) Front Trim - Grime - Medium / (R) Front Floor Mat - Missing - Yes / (L) Front Floor Mat - Missing - Yes / (L) Front Seat - Grime - Small / (R) Front Trim - Grime - Large / (R) Front Seat - Grime - Medium / (R) Rear Trim - Grime - Large / Console, Switches, Vents - Worn, Scratch, Cut, Crack - Small / Ceiling - Grime - Small</p>	<p>Remarks Member (Bolted) - Dent - Yes / (R) Front Fender, Molding - Scratch & Dent - Small / (R) Front Door, Molding - Scratch - Small / (R) Rear Door, Molding - Dent - Large / (R) Rear Fender, Molding - Scratch - Minimal / Rear Bumper, Lamps, Panels - Scratch - Small / Trunk Hood, Rear Gate - Dent - Medium / (L) Rear Fender, Molding - Scratch - Small / (L) Rear Door, Molding - Scratch - Minimal / (L) Mirror - Scratch - Minimal / (L) Front Door, Molding - Scratch - Small / (L) Front Fender, Molding - Scratch - Small / Front Bumper, Grille, Lamps - Crack, Gap - Large / (R) Mirror - Scratch - Minimal / Bonnet, Headlight - Scratch - Small / Roof - Scratch - Medium</p>
