General Information

Make	Toyota	Model	Avanza
YOM	2020	Odo Meter Reading	57,460
Registration No.	NFY6596	Chassis No.	MHKM5EF2FLK024133
CC	1.3	Transmission	A/T
Fuel Type	Gas	Type of Body	Wagon
Colour	Silver

Body / Panel Condition

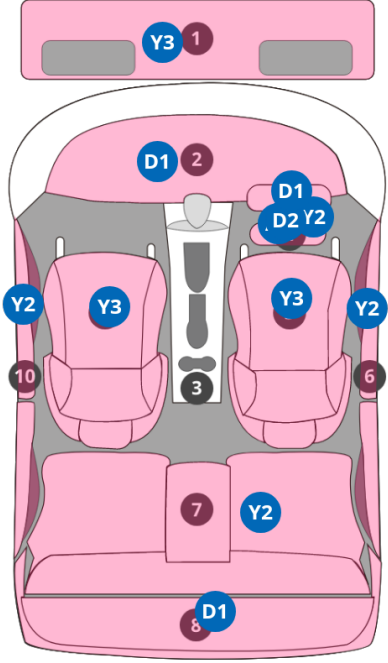
Interior Evaluation : C	Exterior Evaluation : E

<p>a : Cut, Fray d : Loose, Deformed k : Animal Hair s : Smell t : Cigarette Burns x : Defective y : Stain</p>

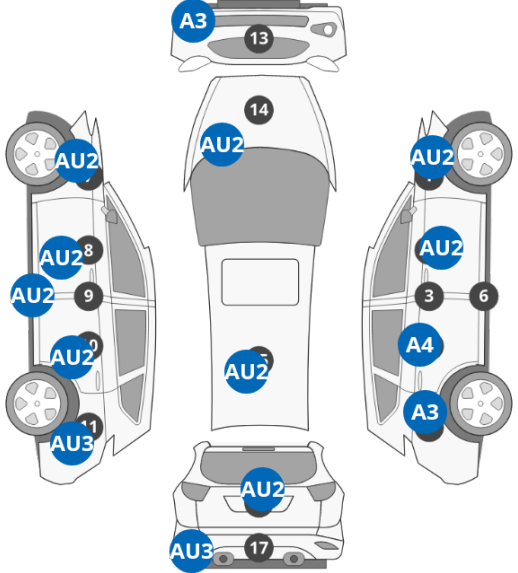
<p>A : Scratch AU : Scratch & Dent B : Modified C : Corrosion G : Stone chip P : Faded S : Rust SC : Rust & Corrosion U : Dent X : Defective Y : Crack, Gap</p>
<p>Remarks (L) Front Trim - Grime - Small / (R) Front Trim - Grime - Small / (R) Front Seat - Grime - Medium / (L) Front Seat - Grime - Medium / (L) Front Floor Mat - Cut, Crack - Medium / (R) Front Floor Mat - Grime - Small / Rear Seat - Grime - Small / Ceiling - Grime - Medium / Dashboard - Worked - Minimal / Mat Other - Worked - Small / Glove Box - Worked - Minimal / Trunk Room - Worked - Minimal</p>	<p>Remarks (R) Front Fender - Repair Traces - Yes / (L) Front Fender - Repair Traces - Yes / (L) Front Door - Repair Traces - Yes / Trunk Hood, Rear Gate - Repair Traces - Yes / (L) Rear Fender, Molding - Scratch & Dent - Medium / (L) Rear Door, Molding - Scratch & Dent - Small / (L) Front Door, Molding - Scratch & Dent - Small / (L) Front Fender, Molding - Scratch & Dent - Small / Bonnet, Headlight - Scratch & Dent - Small / Front Bumper, Grille, Lamps - Scratch - Medium / (R) Front Fender, Molding - Scratch & Dent - Small / (R) Front Door, Molding - Scratch & Dent - Small / (R) Rear Door, Molding - Scratch - Large / (R) Rear Fender, Molding - Scratch - Medium / Trunk Hood, Rear Gate - Scratch & Dent - Small / Rear Bumper, Lamps, Panels - Scratch & Dent - Medium / (L) Step, In-panel, Side Spoiler - Scratch & Dent - Small / Roof - Scratch & Dent - Small</p>
