General Information

Make	Toyota	Model	Hiace
YOM	2022	Odo Meter Reading	30,371
Registration No.	DAQ4941	Chassis No.	JTFJT02P6M0015041
CC	3.0	Transmission	M/T
Fuel Type	Diesel	Type of Body	Van
Colour	Silver

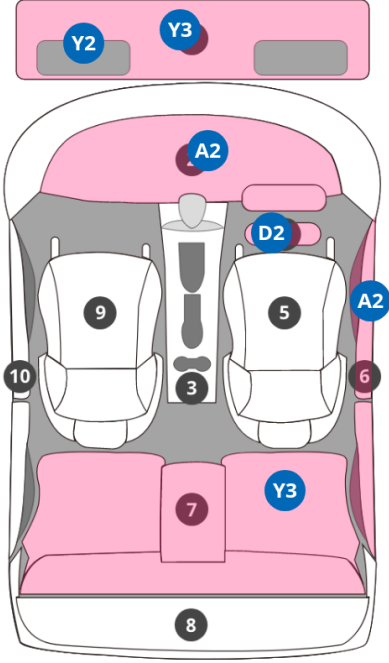
Interior Evaluation : C	Exterior Evaluation : E

<p>a : Cut, Fray d : Loose, Deformed k : Animal Hair s : Smell t : Cigarette Burns x : Defective y : Stain</p>

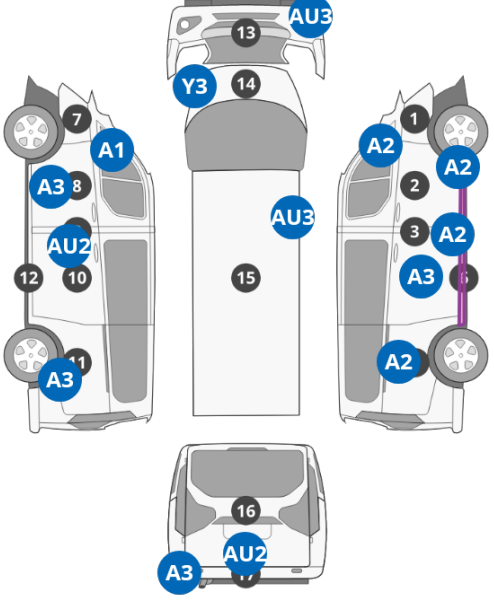
<p>A : Scratch AU : Scratch & Dent B : Modified C : Corrosion G : Stone chip P : Faded S : Rust SC : Rust & Corrosion U : Dent X : Defective Y : Crack, Gap</p>
<p>Remarks Overall Interior - Worn as per age - Yes / (R) Front Trim - Cut, Crack - Small / (L) Front Floor Mat - Worked - Small / Rear Seat - Grime - Medium / Ceiling - Grime - Medium / Dashboard - Worn, Scratch, Cut, Crack - Small / Sunvisor, Sunglass Holder - Grime - Small</p>	<p>Remarks (R) Step - Repair Traces - Yes / (R) Step - Replaced - Yes / Front Panel - Repair Traces - Yes / (R) Rear Door - Repair Traces - Yes / (R) Mirror - Scratch - Small / (R) Front Door, Molding - Scratch - Small / (R) Center Panel - Scratch - Small / (R) Rear Door, Molding - Scratch - Medium / (R) Rear Fender, Molding - Scratch - Small / Rear Bumper, Lamps, Panels - Scratch - Medium / Trunk Hood, Rear Gate - Scratch & Dent - Small / (L) Rear Fender, Molding - Scratch - Medium / (L) Rear Door, Molding - Scratch & Dent - Small / (L) Front Door, Molding - Scratch - Medium / (L) Mirror - Scratch - Minimal / Front Panel - Crack, Gap - Medium / Front Bumper, Grille, Lamps - Scratch & Dent - Medium / Roof - Scratch & Dent - Medium</p>

<p>Inspector Notes</p>
<p>with warranty booklet, with jack and tools, with spare tire, with LTO plate, scratches on tail light and headlight, cracked headlight,</p>
