General Information

Make	Toyota	Model	Vios
YOM	2025	Odo Meter Reading	43,582
Registration No.	DBP6047	Chassis No.	PA1B18F37R4264737
CC	1.3	Transmission	CVT
Fuel Type	Gas	Type of Body	Sedan
Colour	Black

Body / Panel Condition

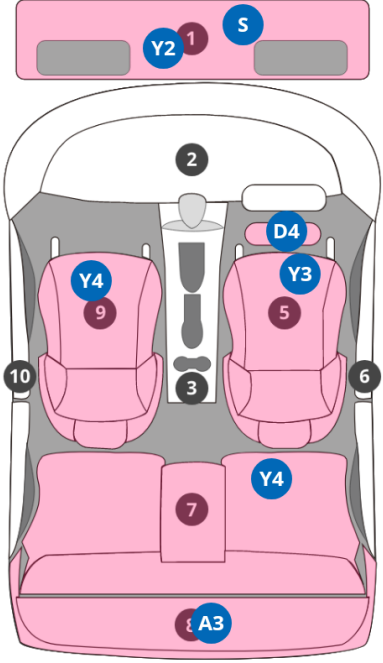
Interior Evaluation : C	Exterior Evaluation : E

<p>a : Cut, Fray d : Loose, Deformed k : Animal Hair s : Smell t : Cigarette Burns x : Defective y : Stain</p>

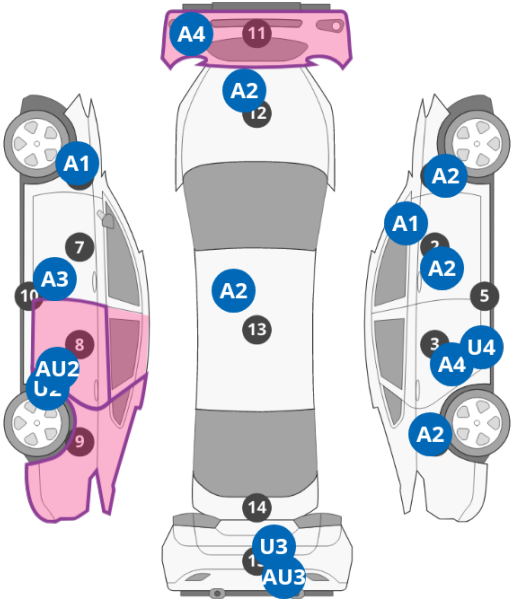
<p>A : Scratch AU : Scratch & Dent B : Modified C : Corrosion G : Stone chip P : Faded S : Rust SC : Rust & Corrosion U : Dent X : Defective Y : Crack, Gap</p>
<p>Remarks Trunk Room - Worn, Scratch, Cut, Crack - Medium / Rear Seat - Grime - Large / (R) Front Seat - Grime - Medium / Ceiling - Grime - Small / (L) Front Floor Mat - Worked - Large / (L) Front Seat - Grime - Large / Overall Interior - Smell - Yes</p>	<p>Remarks (R) Front Fender, Molding - Scratch - Small / (R) Front Door, Molding - Scratch - Small / (R) Mirror - Scratch - Minimal / (R) Rear Door, Molding - Scratch - Large / (R) Step, In-panel, Side Spoiler - Dent - Large / (R) Rear Fender, Molding - Scratch - Small / Rear Bumper, Lamps, Panels - Scratch & Dent - Medium / Trunk Hood, Rear Gate - Dent - Medium / (L) Rear Fender, Molding - Repair mark - Yes / (L) Rear Door, Molding - Repair mark - Yes / (L) Rear Fender, Molding - Dent - Small / (L) Rear Door, Molding - Scratch & Dent - Small / (L) Front Door, Molding - Scratch - Medium / Roof - Scratch - Small / (L) Front Fender, Molding - Scratch - Minimal / Front Bumper, Grille, Lamps - Repair mark - Yes / Front Bumper, Grille, Lamps - Scratch - Large / Bonnet, Headlight - Scratch - Small</p>
