General Information

Make	Toyota	Model	Vios
YOM	2023	Odo Meter Reading	56,155
Registration No.	NHJ3974	Chassis No.	PA1B18F30P4215245
CC	1.3	Transmission	CVT
Fuel Type	Gas	Type of Body	Sedan
Colour	Black

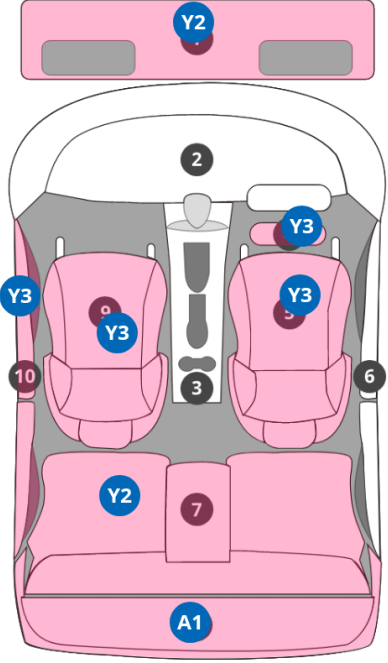
Interior Evaluation : C	Exterior Evaluation : D

<p>a : Cut, Fray d : Loose, Deformed k : Animal Hair s : Smell t : Cigarette Burns x : Defective y : Stain</p>

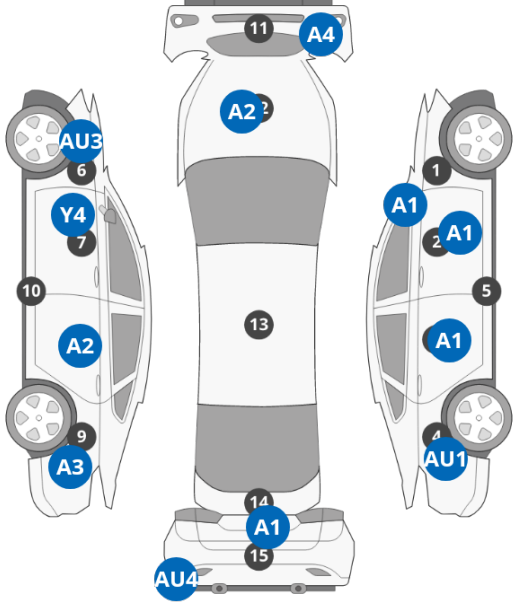
<p>A : Scratch AU : Scratch & Dent B : Modified C : Corrosion G : Stone chip P : Faded S : Rust SC : Rust & Corrosion U : Dent X : Defective Y : Crack, Gap</p>
<p>Remarks Trunk Room - Worn, Scratch, Cut, Crack - Minimal / Rear Seat - Grime - Small / (L) Front Trim - Grime - Medium / (L) Front Floor Mat - Grime - Medium / (L) Front Seat - Grime - Medium / (R) Front Seat - Grime - Medium / Ceiling - Grime - Small</p>	<p>Remarks (R) Front Fender - Repair Traces - Yes / (L) Front Fender - Repair Traces - Yes / (R) Rear Fender - Repair Traces - Yes / Rear Bumper, Lamps, Panels - Scratch & Dent - Large / (L) Rear Fender, Molding - Scratch - Medium / (L) Rear Door, Molding - Scratch - Small / (L) Front Door, Molding - Crack, Gap - Large / (L) Front Fender, Molding - Scratch & Dent - Medium / Front Bumper, Grille, Lamps - Scratch - Large / Bonnet, Headlight - Scratch - Small / (R) Mirror - Scratch - Minimal / (R) Front Door, Molding - Scratch - Minimal / (R) Rear Door, Molding - Scratch - Minimal / (R) Rear Fender, Molding - Scratch & Dent - Minimal / Trunk Hood, Rear Gate - Scratch - Minimal</p>
