General Information

Make	Toyota	Model	Vios
YOM	2024	Odo Meter Reading	6,392
Registration No.	NHN6300	Chassis No.	PA1B18F36R4243327
CC	1.3	Transmission	CVT
Fuel Type	Gas	Type of Body	Sedan
Colour	Red Mica Metallic

Body / Panel Condition

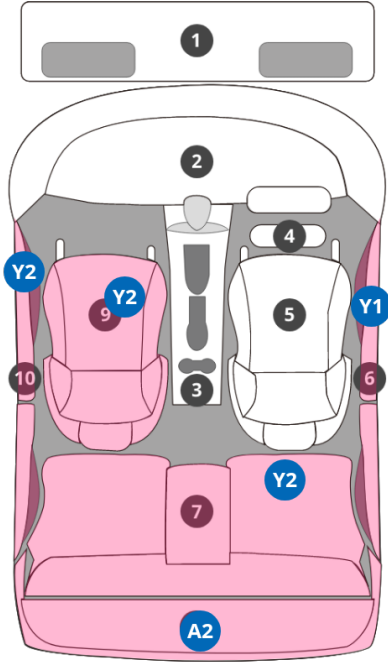
Interior Evaluation : B	Exterior Evaluation : D

<p>a : Cut, Fray d : Loose, Deformed k : Animal Hair s : Smell t : Cigarette Burns x : Defective y : Stain</p>

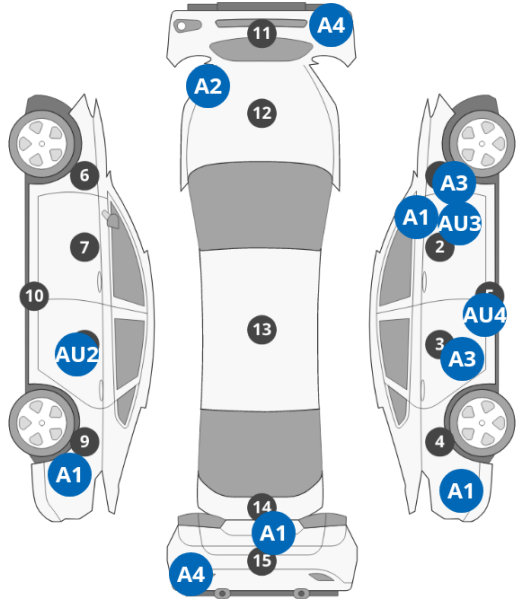
<p>A : Scratch AU : Scratch & Dent B : Modified C : Corrosion G : Stone chip P : Faded S : Rust SC : Rust & Corrosion U : Dent X : Defective Y : Crack, Gap</p>
<p>Remarks Rear Seat - Grime - Small / (R) Front Trim - Grime - Minimal / (L) Front Trim - Grime - Small / (L) Front Seat - Grime - Small / Trunk Room - Worn, Scratch, Cut, Crack - Small</p>	<p>Remarks (R) Front Fender, Molding - Scratch - Medium / (R) Front Door, Molding - Scratch & Dent - Medium / (R) Step, In-panel, Side Spoiler - Scratch & Dent - Large / (R) Rear Door, Molding - Scratch - Medium / Rear Bumper, Lamps, Panels - Scratch - Large / Trunk Hood, Rear Gate - Scratch - Minimal / (L) Rear Door, Molding - Scratch & Dent - Small / Bonnet, Headlight - Scratch - Small / (R) Mirror - Scratch - Minimal / (L) Rear Fender, Molding - Scratch - Minimal / (R) Rear Fender, Molding - Scratch - Minimal / Front Bumper, Grille, Lamps - Scratch - Large</p>
