General Information

Make	Toyota	Model	Vios
YOM	2025	Odo Meter Reading	2,626
Registration No.	NHU8129	Chassis No.	PA1B18F31R4279295
CC	1.3	Transmission	CVT
Fuel Type	Gas	Type of Body	Sedan
Colour	Blue

Body / Panel Condition

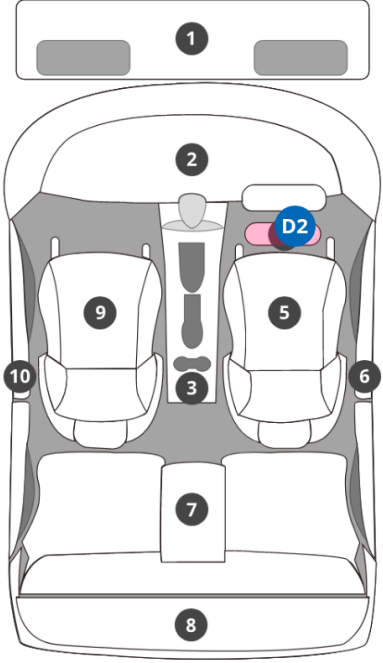
Interior Evaluation : A	Exterior Evaluation : B

<p>a : Cut, Fray d : Loose, Deformed k : Animal Hair s : Smell t : Cigarette Burns x : Defective y : Stain</p>

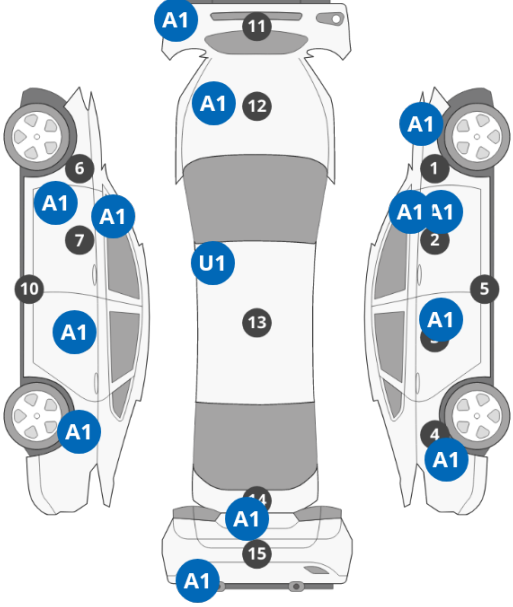
<p>A : Scratch AU : Scratch & Dent B : Modified C : Corrosion G : Stone chip P : Faded S : Rust SC : Rust & Corrosion U : Dent X : Defective Y : Crack, Gap</p>
Remarks (L) Front Floor Mat - Worked - Small	Remarks (R) Front Fender, Molding - Scratch - Minimal / (R) Front Door, Molding - Scratch - Minimal / (R) Mirror - Scratch - Minimal / (R) Rear Door, Molding - Scratch - Minimal / (R) Rear Fender, Molding - Scratch - Minimal / Trunk Hood, Rear Gate - Scratch - Minimal / Rear Bumper, Lamps, Panels - Scratch - Minimal / (L) Rear Fender, Molding - Scratch - Minimal / (L) Rear Door, Molding - Scratch - Minimal / (L) Front Door, Molding - Scratch - Minimal / (L) Mirror - Scratch - Minimal / Roof - Dent - Minimal / Front Bumper, Grille, Lamps - Scratch - Minimal / Bonnet, Headlight - Scratch - Minimal
