General Information

Make	Toyota	Model	Vios
YOM	2023	Odo Meter Reading	90,822
Registration No.	NIM6655	Chassis No.	PA1B18F35P4213555
CC	1.3	Transmission	CVT
Fuel Type	Gas	Type of Body	Sedan
Colour	Black

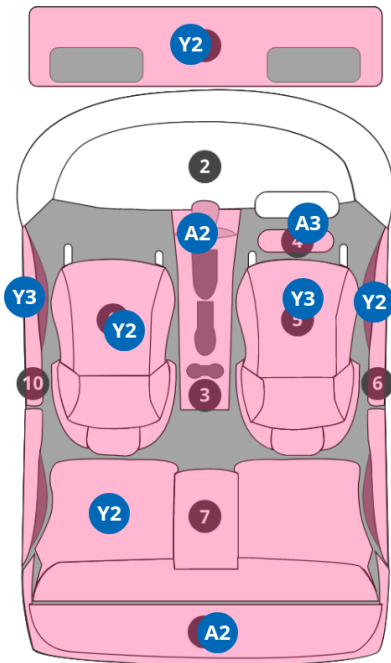
Interior Evaluation : C	Exterior Evaluation : E

<p>a : Cut, Fray d : Loose, Deformed k : Animal Hair s : Smell t : Cigarette Burns x : Defective y : Stain</p>

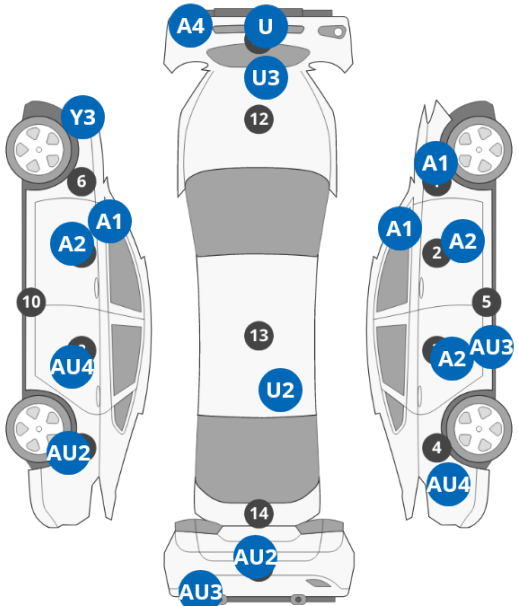
<p>A : Scratch AU : Scratch & Dent B : Modified C : Corrosion G : Stone chip P : Faded S : Rust SC : Rust & Corrosion U : Dent X : Defective Y : Crack, Gap</p>
<p>Remarks (R) Front Seat - Grime - Medium / (R) Front Trim - Grime - Small / Rear Seat - Grime - Small / (L) Front Trim - Grime - Medium / (L) Front Seat - Grime - Small / (L) Front Floor Mat - Cut, Crack - Medium / Ceiling - Grime - Small / Trunk Room - Worn, Scratch, Cut, Crack - Small / Console, Switches, Vents - Worn, Scratch, Cut, Crack - Small</p>	<p>Remarks Member (Bolted) - Dent - Yes / (R) Front Fender, Molding - Scratch - Minimal / Front Bumper, Grille, Lamps - Scratch - Large / Bonnet, Headlight - Dent - Medium / (L) Front Fender, Molding - Crack, Gap - Medium / (L) Mirror - Scratch - Minimal / (L) Front Door, Molding - Scratch - Small / (L) Rear Door, Molding - Scratch & Dent - Large / (L) Rear Fender, Molding - Scratch & Dent - Small / Rear Bumper, Lamps, Panels - Scratch & Dent - Medium / Trunk Hood, Rear Gate - Scratch & Dent - Small / (R) Rear Fender, Molding - Scratch & Dent - Large / (R) Rear Door, Molding - Scratch - Small / (R) Step, In-panel, Side Spoiler - Scratch & Dent - Medium / (R) Front Door, Molding - Scratch - Small / (R) Mirror - Scratch - Minimal / Roof - Dent - Small</p>
