General Information

Make	Toyota	Model	Vios
YOM	2025	Odo Meter Reading	23,653
Registration No.	NJF2989	Chassis No.	PA1B18F34R4276942
CC	1.3	Transmission	CVT
Fuel Type	Gas	Type of Body	Sedan
Colour	Blue

Body / Panel Condition

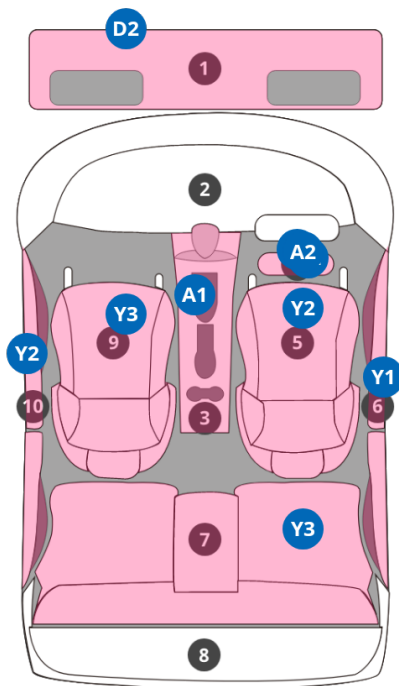
<p>a : Cut, Fray d : Loose, Deformed k : Animal Hair s : Smell t : Cigarette Burns x : Defective y : Stain</p>

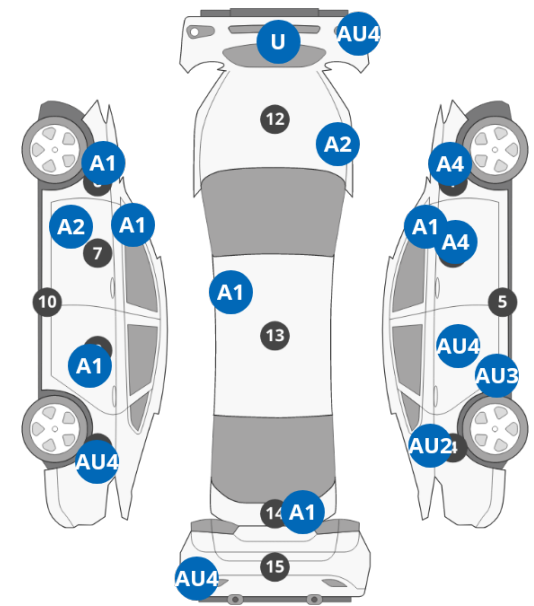
<p>A : Scratch AU : Scratch & Dent B : Modified C : Corrosion G : Stone chip P : Faded S : Rust SC : Rust & Corrosion U : Dent X : Defective Y : Crack, Gap</p>
<p>Remarks Mat Other - Worked - Small / (L) Front Seat - Grime - Medium / (R) Front Seat - Grime - Small / (L) Front Floor Mat - Worked - Small / (L) Front Floor Mat - Cut, Crack - Small / Rear Seat - Grime - Medium / (R) Front Trim - Grime - Minimal / (L) Front Trim - Grime - Small / Ceiling - Crinkle - Small / Console, Switches, Vents - Worn, Scratch, Cut, Crack - Minimal</p>	<p>Remarks (R) Front Fender, Molding - Scratch - Large / (R) Front Door, Molding - Scratch - Large / (R) Rear Door, Molding - Scratch & Dent - Large / (R) Step, In-panel, Side Spoiler - Scratch & Dent - Medium / (R) Mirror - Scratch - Minimal / (R) Rear Fender, Molding - Scratch & Dent - Small / Rear Bumper, Lamps, Panels - Scratch & Dent - Large / (L) Rear Fender, Molding - Scratch & Dent - Large / Trunk Hood, Rear Gate - Scratch - Minimal / (L) Front Door, Molding - Scratch - Small / (L) Rear Door, Molding - Scratch - Minimal / (L) Mirror - Scratch - Minimal / Member (Bolted) - Dent - Yes / (L) Front Fender, Molding - Scratch - Minimal / Front Bumper, Grille, Lamps - Scratch & Dent - Large / Bonnet, Headlight - Scratch - Small / Roof - Scratch - Minimal</p>

<p>Inspector Notes</p>
<p>with warranty booklet, with jack, incomplete tools, with spare tire, with LTO plate, scratched and cracked tail light</p>
