General Information

Make	Toyota	Model	Rush
YOM	2025	Odo Meter Reading	5,156
Registration No.	NJF1187	Chassis No.	MHKE8FF3PRK063467
CC	1.5	Transmission	A/T
Fuel Type	Gas	Type of Body	SUV
Colour	Red

Body / Panel Condition

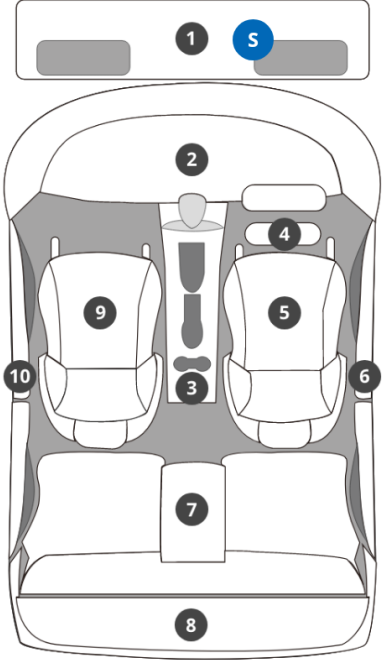
Interior Evaluation : B	Exterior Evaluation : B

<p>a : Cut, Fray d : Loose, Deformed k : Animal Hair s : Smell t : Cigarette Burns x : Defective y : Stain</p>

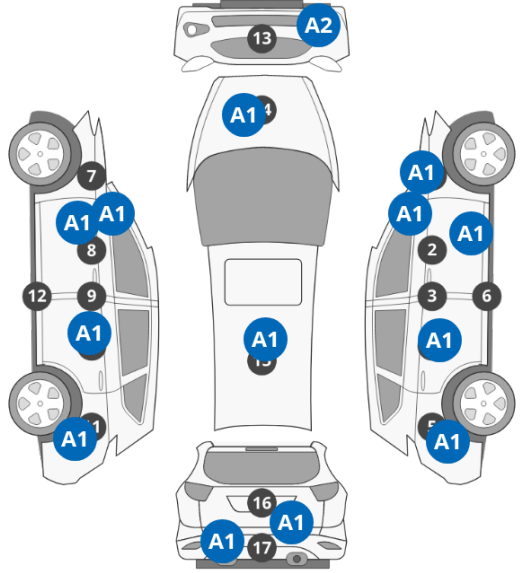
<p>A : Scratch AU : Scratch & Dent B : Modified C : Corrosion G : Stone chip P : Faded S : Rust SC : Rust & Corrosion U : Dent X : Defective Y : Crack, Gap</p>
Remarks Overall Interior - Smell - Yes	Remarks (L) Rear Fender, Molding - Scratch - Minimal / (L) Rear Door, Molding - Scratch - Minimal / (L) Front Door, Molding - Scratch - Minimal / (L) Mirror - Scratch - Minimal / Bonnet, Headlight - Scratch - Minimal / Front Bumper, Grille, Lamps - Scratch - Small / (R) Mirror - Scratch - Minimal / (R) Front Fender, Molding - Scratch - Minimal / (R) Front Door, Molding - Scratch - Minimal / (R) Rear Door, Molding - Scratch - Minimal / (R) Rear Fender, Molding - Scratch - Minimal / Trunk Hood, Rear Gate - Scratch - Minimal / Rear Bumper, Lamps, Panels - Scratch - Minimal / Roof - Scratch - Minimal

Inspector Notes
With LTO plate and Sparetire and Jack and Incomplete Tools, No warranty booklet and Scratch headlight and tail light.
