General Information

Make	Toyota	Model	Wigo
YOM	2022	Mileage	43,248
Registration No.	CAX5246	Chassis No.	MHKA4DF5FNJ066251
CC	1.0	Transmission	A/T
Fuel Type	Gas	Type of Body	Hatchback
Colour	Gray

Body / Panel Condition

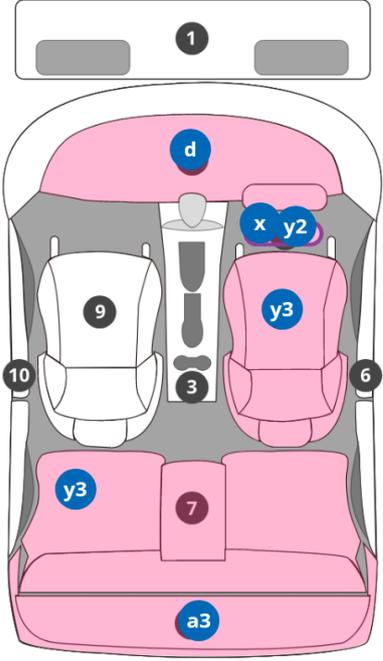
Interior Evaluation : B	Exterior Evaluation : C

<p>a : Cut, Fray d : Loose, Deformed k : Animal Hair s : Smell t : Cigarette Burns x : Defective y : Stain</p>

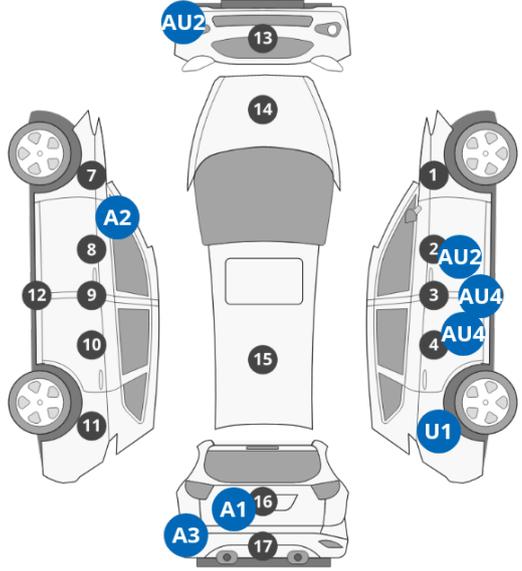
<p>A : Scratch AU : Scratch & Dent B : Modified C : Corrosion G : Stone chip P : Faded S : Rust SC : Rust & Corrosion U : Dent X : Defective Y : Crack, Gap</p>
<p>Remarks Dashboard - Traces of Adhesive Tape - Yes / (R) Front Floor Mat - Grime - Small / Rear Seat - Grime - Medium / Mat Other - Missing - Yes / Trunk Room - Worn, Scratch, Cut, Crack - Medium / (R) Front Seat - Grime - Medium</p>	<p>Remarks (R) Rear Door, Molding - Scratch & Dent - Large / (R) Step, In-panel, Side Spoiler - Scratch & Dent - Large / (R) Front Door, Molding - Scratch & Dent - Small / (R) Rear Fender, Molding - Dent - Minimal / Rear Bumper, Lamps, Panels - Scratch - Medium / (L) Mirror - Scratch - Small / Front Bumper, Grille, Lamps - Scratch & Dent - Small / Trunk Hood, Rear Gate - Scratch - Minimal</p>

<p>Inspector Notes</p>
<p>swirlmarks and hairline scratches around the exterior. without warranty booklet, user manual and tools.</p>
