General Information

Make	Toyota	Model	Vios
YOM	2022	Odo Meter Reading	22,788
Registration No.	NFD9673	Chassis No.	PA1B18F31N4174749
CC	1.3	Transmission	M/T
Fuel Type	Gas	Type of Body	Sedan
Colour	Blue

Body / Panel Condition

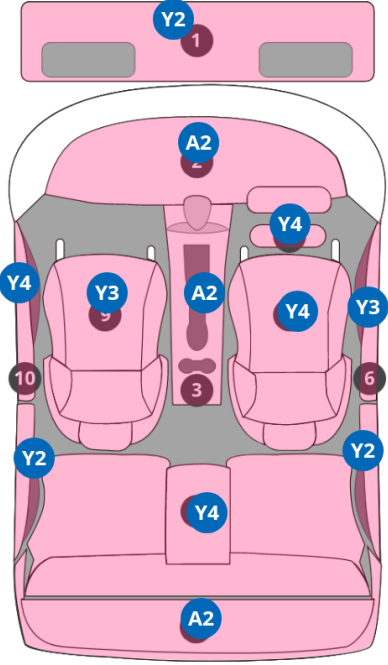
Interior Evaluation : E	Exterior Evaluation : E

<p>a : Cut, Fray d : Loose, Deformed k : Animal Hair s : Smell t : Cigarette Burns x : Defective y : Stain</p>

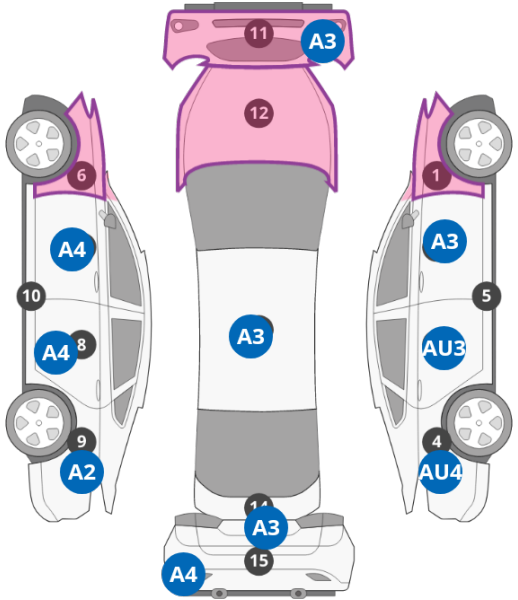
<p>A : Scratch AU : Scratch & Dent B : Modified C : Corrosion G : Stone chip P : Faded S : Rust SC : Rust & Corrosion U : Dent X : Defective Y : Crack, Gap</p>
Remarks (R) Front Seat - Grime - Large / (R) Front Trim - Grime - Medium / Rear Seat - Grime - Large / (R) Rear Trim - Grime - Small / (L) Rear Trim - Grime - Small / (L) Front Trim - Grime - Large / (L) Front Seat - Grime - Medium / Dashboard - Worn, Scratch, Cut, Crack - Small / (L) Front Floor Mat - Grime - Large / Ceiling - Grime - Small / Console, Switches, Vents - Worn, Scratch, Cut, Crack - Small / Trunk Room - Worn, Scratch, Cut, Crack - Small	Remarks (R) Front Fender - Repair Traces - Yes / Bonnet - Repair Traces - Yes / (L) Front Fender - Repair Traces - Yes / Bonnet, Headlight - Repair mark - Yes / (L) Front Fender, Molding - Repair mark - Yes / (R) Front Fender, Molding - Repair mark - Yes / Front Bumper, Grille, Lamps - Repair mark - Yes / Front Bumper, Grille, Lamps - Scratch - Medium / (R) Front Door, Molding - Scratch - Medium / (R) Rear Door, Molding - Scratch & Dent - Medium / (R) Rear Fender, Molding - Scratch & Dent - Large / Rear Bumper, Lamps, Panels - Scratch - Large / Trunk Hood, Rear Gate - Scratch - Medium / (L) Rear Fender, Molding - Scratch - Small / (L) Rear Door, Molding - Scratch - Large / (L) Front Door, Molding - Scratch - Large / Roof - Scratch - Medium
