General Information

Make	Ford	Model	Escape
YOM	2012	Odo Meter Reading	117,114
Registration No.	TIS435	Chassis No.	PE2EV222C1GP00812
CC	2.3	Transmission	A/T
Fuel Type	Gas	Type of Body	SUV
Colour	White

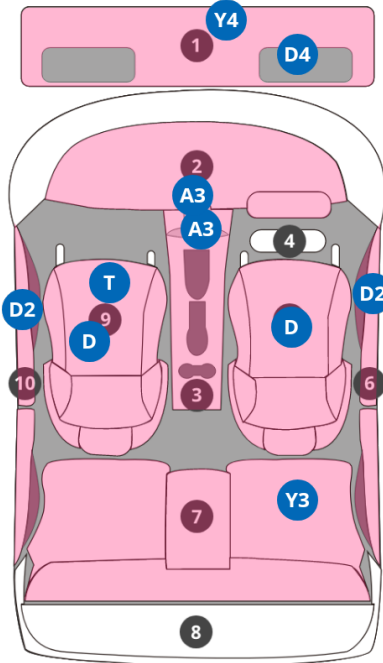
<p>a : Cut, Fray d : Loose, Deformed k : Animal Hair s : Smell t : Cigarette Burns x : Defective y : Stain</p>

<p>A : Scratch AU : Scratch & Dent B : Modified C : Corrosion G : Stone chip P : Faded S : Rust SC : Rust & Corrosion U : Dent X : Defective Y : Crack, Gap</p>
Remarks Overall Interior - Worn as per age - Yes / (L) Front Seat - Cigarette Burns - Burnt, Hole / Ceiling - Grime - Large / Switchs - Partially Missing - Yes / Switchs - Partially Missing - Yes / (R) Front Trim - Worked - Small / (L) Front Trim - Worked - Small / (R) Front Seat - Worn - Yes / (L) Front Seat - Worn - Yes / Knobs - Worn, Peel, Crack - Medium / Dashboard - Worn, Scratch, Cut, Crack - Medium / Sunvisor, Sunglass Holder - Worked - Large / Rear Seat - Grime - Medium	Remarks (R) Front Fender - Repair Traces - Yes / Bonnet - Repair Traces - Yes / (L) Front Fender - Repair Traces - Yes / (L) Rear Door - Repair Traces - Yes / (L) Rear Fender - Repair Traces - Yes / (L) Rear Fender, Molding - Repair mark - Yes / (R) Rear Fender, Molding - Repair mark - Yes / Trunk Hood, Rear Gate - Scratch - Large / Rear Bumper, Lamps, Panels - Repair mark - Yes / Rear Bumper, Lamps, Panels - Scratch & Dent - Large / (R) Rear Fender, Molding - Scratch - Large / (R) Rear Door, Molding - Scratch - Large / (R) Step, In-panel, Side Spoiler - Scratch - Large / (R) Front Door, Molding - Scratch - Large / Roof - Scratch & Dent - Medium / (R) Front Fender, Molding - Scratch - Medium / Front Bumper, Grille, Lamps - Crack, Gap - Large / Bonnet, Headlight - Scratch - Medium / (L) Front Fender, Molding - Scratch - Large / (L) Front Door, Molding - Scratch & Dent - Large / (L) Rear Door, Molding - Scratch - Medium / (L) Rear Fender, Molding - Scratch - Medium

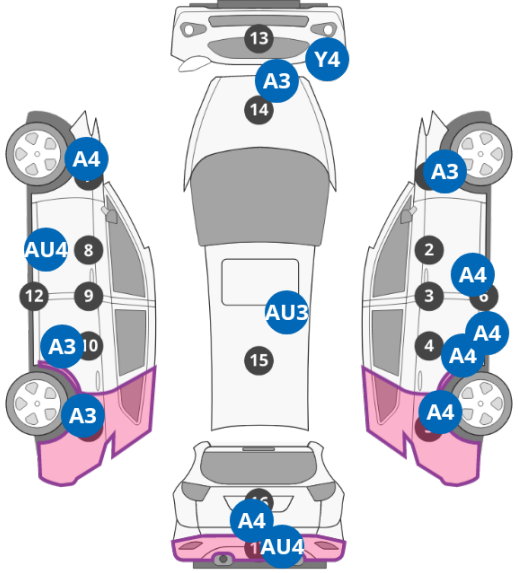
Frame Evaluation : B	Functional Evaluation : E
Remarks Front Cross Member Support - Traces of Bending, or Marks of Panel Repair ? - Yes	Remarks Warning Lamps - Issue - Yes / Panel, Meter - Issue - Yes / Power Window (each) - Stuck, Gap - Yes / Air Conditioner - Function - Weak / Battery - Weak - Yes / Remote Key & Smart entry - Issue - Yes / Audio, Radio - Issue - Yes / Reverse Camera - N/A - Yes / Brake Pedal - Function - Weak / Head Light, High Beam - Issue - Yes / Wiper - Function - Weak / Spare Key - Issue - Unexist
