## General Information

| Make | Toyota | Model | Vios |

## Body / Panel Condition

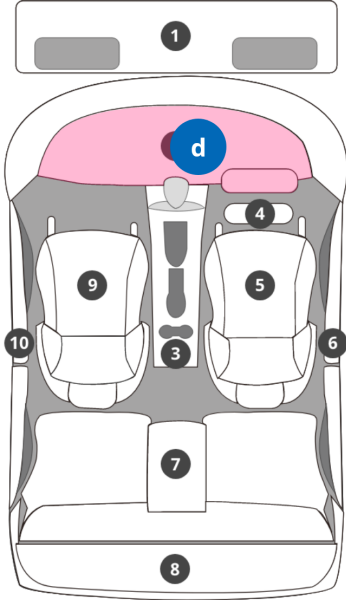
| <b>Interior Evaluation :</b> <span style="color: red; font-weight: bold;">A</span> | <b>Exterior Evaluation :</b> <span style="color: red; font-weight: bold;">A</span> |
| <b>Remarks</b><br>Dashboard - Traces of Adhesive Tape - Yes | <b>Remarks</b><br>(L) Rear Fender, Molding - Scratch - Minimal / Member (Bolted) - Dent - Yes |
