## General Information

<b>Make</b>	Mitsubishi	<b>Model</b>	Mirage
<b>YOM</b>	2024	<b>Odo Meter Reading</b>	17,168
<b>Registration No.</b>	DBO5527	<b>Chassis No.</b>	PAEA13RXRPA017659
<b>CC</b>	1.2	<b>Transmission</b>	CVT
<b>Fuel Type</b>	Gas	<b>Type of Body</b>	Sedan
<b>Colour</b>	Red

## Body / Panel Condition

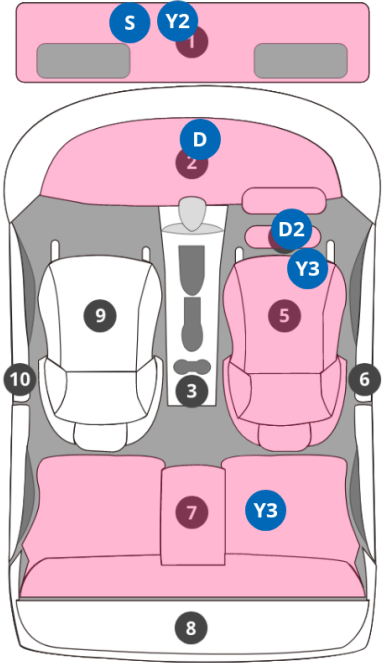
<b>Interior Evaluation :</b> <span style="float: right; color: red; font-weight: bold;">B</span>	<b>Exterior Evaluation :</b> <span style="float: right; color: red; font-weight: bold;">E</span>

<p><b>a</b> : Cut, Fray <b>d</b> : Loose, Deformed <b>k</b> : Animal Hair <b>s</b> : Smell <b>t</b> : Cigarette Burns <b>x</b> : Defective <b>y</b> : Stain</p>

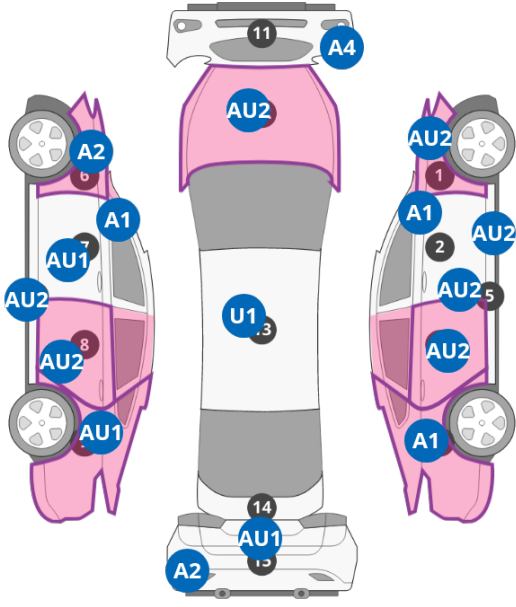
<p><b>A</b> : Scratch <b>AU</b> : Scratch &amp; Dent <b>B</b> : Modified <b>C</b> : Corrosion <b>G</b> : Stone chip <b>P</b> : Faded <b>S</b> : Rust <b>SC</b> : Rust &amp; Corrosion <b>U</b> : Dent <b>X</b> : Defective <b>Y</b> : Crack, Gap</p>
<p><b>Remarks</b> Overall Interior - Smell - Yes / Ceiling - Grime - Small / Rear Seat - Grime - Medium / (R) Front Seat - Grime - Medium / (L) Front Floor Mat - Worked - Small / Dashboard - Traces of Adhesive Tape - Yes</p>	<p><b>Remarks</b> (R) Front Fender - Repair Traces - Yes / Bonnet - Repair Traces - Yes / (L) Front Fender - Repair Traces - Yes / (L) Rear Door - Repair Traces - Yes / (L) Rear Fender - Repair Traces - Yes / (R) Rear Fender - Repair Traces - Yes / (R) Rear Door - Repair Traces - Yes / (L) Front Fender, Molding - Repair mark - Yes / (L) Rear Door, Molding - Repair mark - Yes / (R) Rear Fender, Molding - Repair mark - Yes / (R) Rear Door, Molding - Repair mark - Yes / (R) Front Fender, Molding - Repair mark - Yes / Bonnet, Headlight - Repair mark - Yes / (R) Front Door, Molding - Scratch &amp; Dent - Small / (R) Step, In-panel, Side Spoiler - Scratch &amp; Dent - Small / (R) Rear Door, Molding - Scratch &amp; Dent - Small / (R) Rear Fender, Molding - Scratch - Minimal / (R) Mirror - Scratch - Minimal / (R) Front Fender, Molding - Scratch &amp; Dent - Small / Front Bumper, Grille, Lamps - Scratch - Large / (L) Front Fender, Molding - Scratch - Small / (L) Mirror - Scratch - Minimal / (L) Front Door, Molding - Scratch &amp; Dent - Minimal / (L) Rear Door, Molding - Scratch &amp; Dent - Small / (L) Rear Fender, Molding - Scratch &amp; Dent - Minimal / (L) Step, In-panel, Side Spoiler - Scratch &amp; Dent - Small / Roof - Dent - Minimal / Bonnet, Headlight - Scratch &amp; Dent - Small / Trunk Hood, Rear Gate - Scratch &amp; Dent - Minimal / Rear Bumper, Lamps, Panels - Scratch - Small</p>
