## General Information

<b>Make</b>	Mitsubishi	<b>Model</b>	Mirage
<b>YOM</b>	2021	<b>Odo Meter Reading</b>	34,200
<b>Registration No.</b>	NEV2415	<b>Chassis No.</b>	PAEA13RJMMMA020434
<b>CC</b>	1.2	<b>Transmission</b>	A/T
<b>Fuel Type</b>	Gas	<b>Type of Body</b>	Sedan
<b>Colour</b>	Silver

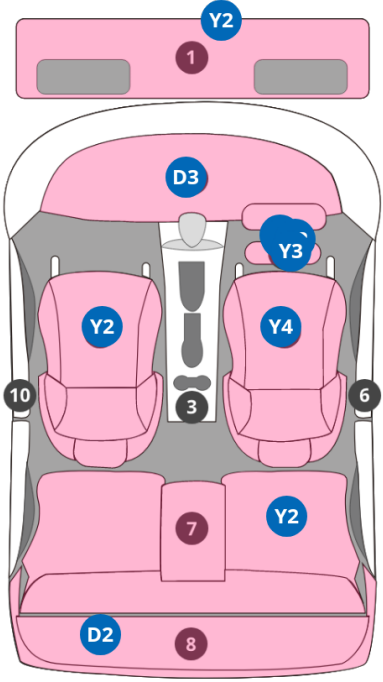
<p><b>a</b> : Cut, Fray <b>d</b> : Loose, Deformed <b>k</b> : Animal Hair <b>s</b> : Smell <b>t</b> : Cigarette Burns <b>x</b> : Defective <b>y</b> : Stain</p>

<p><b>A</b> : Scratch <b>AU</b> : Scratch &amp; Dent <b>B</b> : Modified <b>C</b> : Corrosion <b>G</b> : Stone chip <b>P</b> : Faded <b>S</b> : Rust <b>SC</b> : Rust &amp; Corrosion <b>U</b> : Dent <b>X</b> : Defective <b>Y</b> : Crack, Gap</p>
<p><b>Remarks</b> Overall Interior - Smell - Yes / Overall Interior - Animal Hair - Yes / Ceiling - Grime - Small / (R) Front Seat - Grime - Large / (L) Front Floor Mat - Worked - Small / (R) Front Floor Mat - Grime - Medium / Dashboard - Loose, Deformed - Medium / Rear Seat - Grime - Small / Trunk Room - Loose, Deformed - Small / (L) Front Seat - Grime - Small</p>	<p><b>Remarks</b> (L) Rear Fender, Molding - Scratch &amp; Dent - Small / (L) Rear Door, Molding - Dent - Minimal / (L) Front Door, Molding - Scratch &amp; Dent - Minimal / (L) Step, In-panel, Side Spoiler - Scratch &amp; Dent - Minimal / (L) Front Fender, Molding - Scratch - Minimal / Bonnet, Headlight - Scratch &amp; Dent - Small / Trunk Hood, Rear Gate - Scratch &amp; Dent - Small / Rear Bumper, Lamps, Panels - Scratch - Minimal / (L) Mirror - Scratch - Minimal / Front Bumper, Grille, Lamps - Scratch - Medium / (R) Front Fender, Molding - Dent - Minimal / (R) Front Door, Molding - Dent - Small / (R) Rear Door, Molding - Scratch &amp; Dent - Minimal / (R) Step, In-panel, Side Spoiler - Scratch &amp; Dent - Small / Roof - Scratch - Small / (R) Rear Fender, Molding - Scratch &amp; Dent - Minimal</p>
