## General Information

| Make | Toyota | Model | Vios |
| YOM | 2021 | Odo Meter Reading | 39,192 |
| Registration No. | FAF3186 | Chassis No. | PA1B18F38L4130857 |

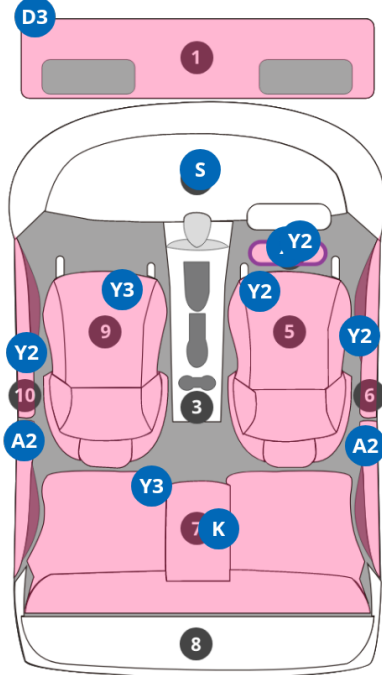
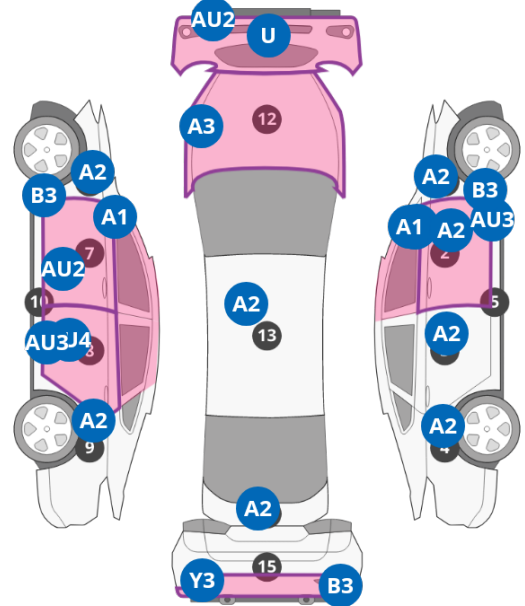
| Interior Evaluation : <span style="color: red;">C</span> | Exterior Evaluation : <span style="color: red;">E</span> |
|---|---|
| <p><b>a</b> : Cut, Fray <b>d</b> : Loose, Deformed <b>k</b> : Animal Hair <b>s</b> : Smell <b>t</b> : Cigarette Burns <b>x</b> : Defective <b>y</b> : Stain</p> | <p><b>A</b> : Scratch <b>AU</b> : Scratch &amp; Dent <b>B</b> : Modified <b>C</b> : Corrosion <b>G</b> : Stone chip <b>P</b> : Faded <b>S</b> : Rust <b>SC</b> : Rust &amp; Corrosion <b>U</b> : Dent <b>X</b> : Defective <b>Y</b> : Crack, Gap</p> |
| <p><b>Remarks</b></p> <p>Overall Interior - Smell - Yes / Overall Interior - Animal Hair - Yes / Rear Seat - Grime - Medium / (R) Rear Trim - Cut, Crack - Small / (L) Rear Trim - Cut, Crack - Small / Mat Other - Missing - Yes / (R) Front Seat - Grime - Small / (R) Front Floor Mat - Grime - Small / Ceiling - Crinkle - Medium / (R) Front Trim - Grime - Small / (L) Front Trim - Grime - Small / (L) Front Seat - Grime - Medium</p> | <p><b>Remarks</b></p> <p>(R) Front Fender - Repair Traces - Yes / (L) Front Fender - Repair Traces - Yes / (L) Rear Fender - Repair Traces - Yes / (R) Rear Fender - Repair Traces - Yes / Roof - Repair Traces - Yes / Member (Bolted) - Dent - Yes / (R) Front Fender, Molding - Scratch - Small / (R) Mirror - Faded(Color, Gloss) - Yes / (R) Mirror - Stuck - Yes / (R) Mirror - Scratch - Minimal / (R) Front Door, Molding - Repair mark - Yes / (R) Front Door, Molding - Scratch - Small / (R) Step, In-panel, Side Spoiler - Scratch &amp; Dent - Medium / (R) Rear Door, Molding - Scratch - Small / (R) Rear Fender, Molding - Scratch - Small / Rear Bumper, Lamps, Panels - Modified - Medium / (R) Front Fender, Molding - Modified - Medium / Rear Bumper, Lamps, Panels - Repair mark - Yes / Rear Bumper, Lamps, Panels - Crack, Gap - Medium / Trunk Hood, Rear Gate - Scratch - Small / (L) Rear Fender, Molding - Scratch - Small / (L) Rear Door, Molding - Scratch &amp; Dent - Large / (L) Front Door, Molding - Repair mark - Yes / (L) Rear Door, Molding - Repair mark - Yes / (L) Step, In-panel, Side Spoiler - Scratch &amp; Dent - Medium / (L) Front Door, Molding - Scratch &amp; Dent - Small / (L) Mirror - Scratch - Minimal / (L) Front Fender, Molding - Modified - Medium / (L) Front Fender, Molding - Scratch - Small / Front Bumper, Grille, Lamps - Repair mark - Yes / Front Bumper, Grille, Lamps - Scratch &amp; Dent - Small / Bonnet, Headlight - Repair mark - Yes / Bonnet, Headlight - Scratch - Medium / Roof - Scratch - Small</p> |
