## General Information

| Make | Toyota | Model | Vios |

## Body / Panel Condition

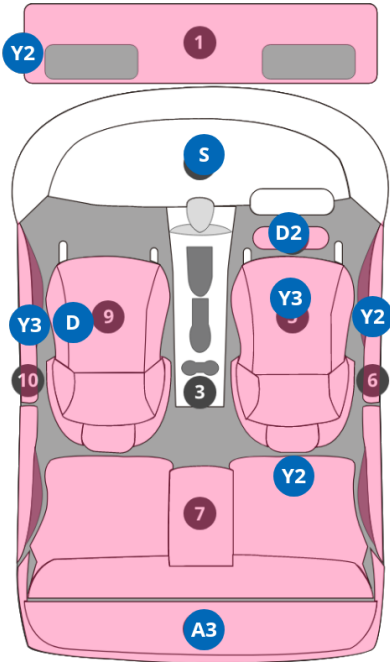
| Interior Evaluation : <span>C</span> | Exterior Evaluation : <span>E</span> |
| <b>Remarks</b><br>Overall Interior - Smell - Yes / Rear Seat - Grime - Small / (R) Front Seat - Grime - Medium / (L) Front Seat - Worn - Yes / (L) Front Trim - Grime - Medium / (R) Front Trim - Grime - Small / Ceiling - Grime - Small / (L) Front Floor Mat - Worked - Small / Trunk Room - Worn, Scratch, Cut, Crack - Medium | <b>Remarks</b><br>(R) Front Fender - Repair Traces - Yes / (L) Rear Fender - Repair Traces - Yes / (R) Front Fender, Molding - Scratch - Small / (R) Mirror - Scratch - Small / (R) Rear Door, Molding - Scratch & Dent - Medium / (R) Rear Fender, Molding - Scratch & Dent - Medium / (R) Front Door, Molding - Scratch - Small / Rear Bumper, Lamps, Panels - Scratch - Medium / Trunk Hood, Rear Gate - Scratch & Dent - Medium / (L) Rear Fender, Molding - Scratch - Small / (L) Rear Door, Molding - Scratch - Medium / (L) Front Door, Molding - Scratch - Small / (L) Mirror - Scratch - Small / (L) Front Fender, Molding - Dent - Medium / Member (Bolted) - Dent - Yes / Front Bumper, Grille, Lamps - Repair mark - Yes / Front Bumper, Grille, Lamps - Scratch & Dent - Medium / Roof - Dent - Small / Bonnet, Headlight - Crack, Gap - Large |

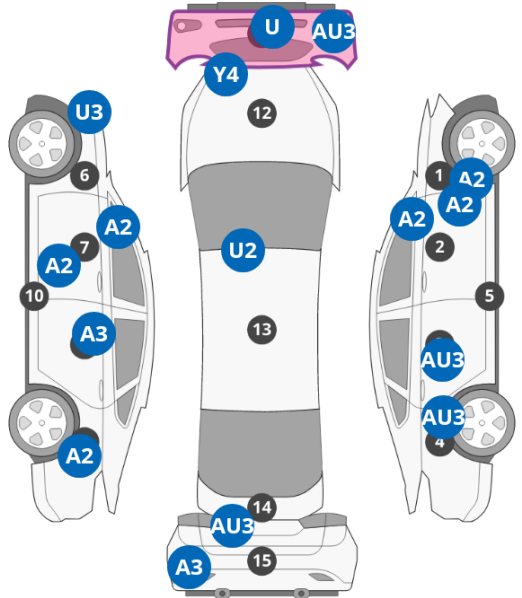
no warranty booklet, with jack and incomplete tools, with spare tire, with LTO plate, possible flooding, scratches on tail light, cracked headlight,
