General Information

Make	Toyota	Model	Vios
YOM	2021	Odo Meter Reading	76,816
Registration No.	FAL7946	Chassis No.	PA1B18F38L4124377
CC	1.3	Transmission	CVT
Fuel Type	Gas	Type of Body	Sedan
Colour	Blue

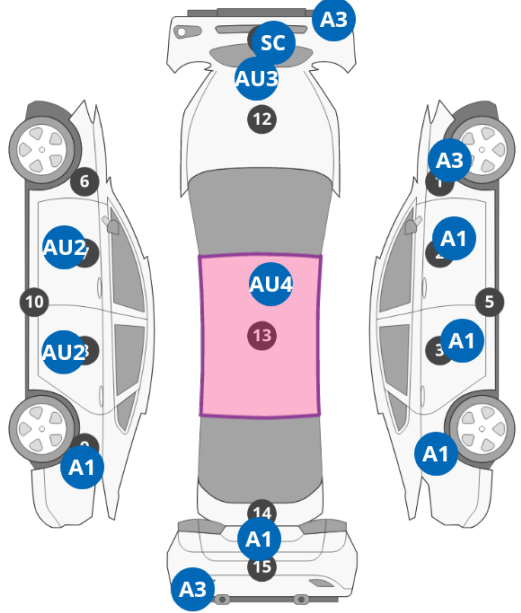
</div> <p>A : Scratch AU : Scratch & Dent B : Modified C : Corrosion G : Stone chip P : Faded S : Rust SC : Rust & Corrosion U : Dent X : Defective Y : Crack, Gap</p>
<p>Remarks Steering Wheel - Worn, Peel, Crack - Large / (L) Front Seat - Grime - Medium / Rear Seat - Grime - Medium / (R) Front Seat - Grime - Medium / Dashboard - Worn, Scratch, Cut, Crack - Small / Trunk Room - Worn, Scratch, Cut, Crack - Medium / (L) Front Trim - Grime - Medium / Ceiling - Grime - Medium / (R) Front Trim - Grime - Medium</p>	<p>Remarks Bonnet, Headlight - Scratch & Dent - Medium / Roof - Scratch & Dent - Large / Roof - Repair mark - Yes / (R) Front Fender, Molding - Scratch - Medium / (R) Front Door, Molding - Scratch - Minimal / (R) Rear Fender, Molding - Scratch - Minimal / (R) Rear Door, Molding - Scratch - Minimal / Trunk Hood, Rear Gate - Scratch - Minimal / (L) Rear Door, Molding - Scratch & Dent - Small / Rear Bumper, Lamps, Panels - Scratch - Medium / (L) Front Door, Molding - Scratch & Dent - Small / (L) Rear Fender, Molding - Scratch - Minimal / Front Bumper, Grille, Lamps - Scratch - Medium / Member (Bolted) - Rust, Corrosion - Yes</p>

<p>Inspector Notes</p>
<p>with LTO plate/spare tire damage/No warranty booklet/No reverse camera/No jack and tools/ high beam issue/No spare key// bonnet hood left and right traces of repair and bolted/Audio volume issue/inside the vehicle dirty</p>
