## General Information

| Make | Toyota | Model | Vios |

## Body / Panel Condition

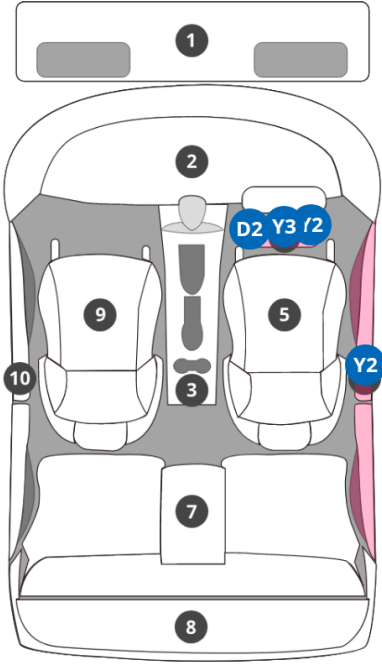
| Interior Evaluation : <b>B</b> | Exterior Evaluation : <b>D</b> |
| <b>Remarks</b><br>(R) Front Floor Mat - Grime - Small / (R) Front Trim - Grime - Small / Mat Other - Grime - Medium / (L) Front Floor Mat - Worked - Small | <b>Remarks</b><br>(L) Front Fender - Repair Traces - Yes / (L) Rear Door, Molding - Scratch & Dent - Small / (L) Front Fender, Molding - Repair mark - Yes / (L) Mirror - Crack - Damaged / Front Bumper, Grille, Lamps - Scratch & Dent - Large / (R) Mirror - Scratch - Minimal / (R) Front Fender, Molding - Scratch - Small / (R) Rear Door, Molding - Scratch - Minimal / (R) Step, In-panel, Side Spoiler - Scratch & Dent - Small / Trunk Hood, Rear Gate - Scratch - Medium / Rear Bumper, Lamps, Panels - Scratch - Small / (L) Rear Fender, Molding - Scratch - Medium |

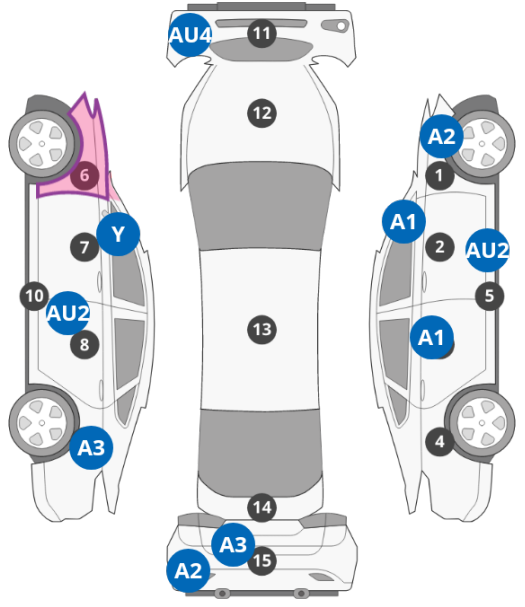
| Inspector Notes |
|---|
| Crack left taillight. Taillight issue. Left side mirror loose. Toe hook cover missing. 1 key. Without warranty booklet,jack and tools. With spare tire and seat cover. No LTO plate. |
