## General Information

| Make | Toyota | Model | Vios |
| YOM | 2023 | Odo Meter Reading | 10,876 |
| Registration No. | FAO6493 | Chassis No. | PA1B18F3XP4208853 |

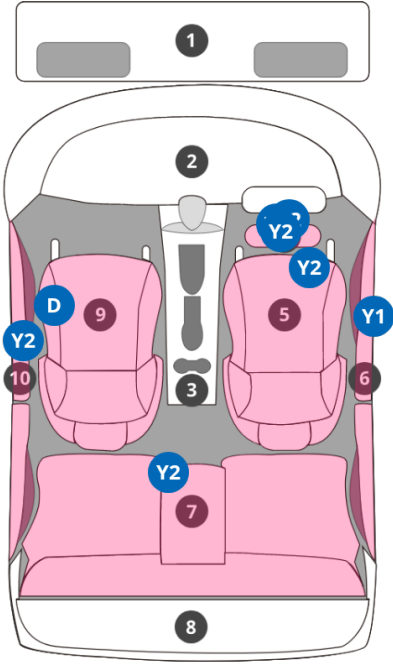
| Interior Evaluation : <b>B</b> | Exterior Evaluation : <b>E</b> |
| <b>Remarks</b><br>Rear Seat - Grime - Small / (L) Front Trim - Grime - Small / (L) Front Seat - Worn - Yes / (R) Front Trim - Grime - Minimal / (R) Front Seat - Grime - Small / (L) Front Floor Mat - Worked - Small / (R) Front Floor Mat - Grime - Small / Mat Other - Grime - Small | <b>Remarks</b><br>(R) Front Door, Molding - Scratch & Dent - Small / (R) Front Fender, Molding - Scratch - Minimal / (R) Mirror - Scratch - Small / (R) Mirror - Crack - Damaged / (R) Rear Door, Molding - Scratch & Dent - Small / (R) Rear Fender, Molding - Scratch & Dent - Small / Rear Bumper, Lamps, Panels - Scratch - Small / (L) Rear Door, Molding - Repair mark - Yes / (L) Rear Door, Molding - Scratch - Medium / Trunk Hood, Rear Gate - Scratch - Minimal / (L) Rear Fender, Molding - Scratch - Minimal / (L) Front Door, Molding - Scratch - Small / (L) Front Fender, Molding - Modified - Small / (R) Front Fender, Molding - Modified - Small / Rear Bumper, Lamps, Panels - Modified - Small / (L) Rear Fender, Molding - Modified - Small / (L) Front Fender, Molding - Scratch - Minimal / Front Bumper, Grille, Lamps - Scratch - Medium / Bonnet, Headlight - Scratch - Small / Roof - Scratch - Large |

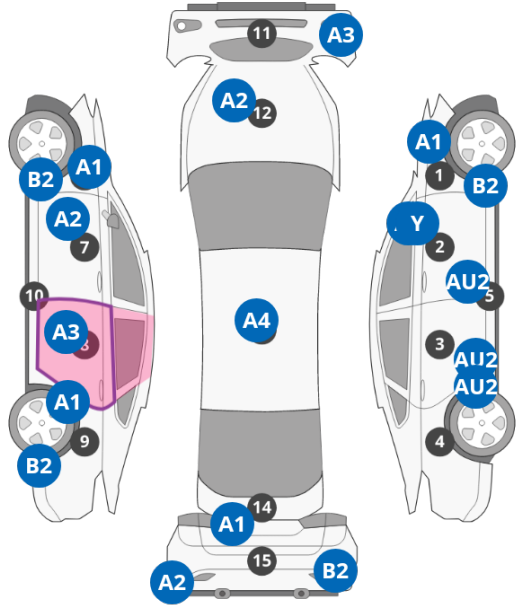
no warranty booklet, no jack and tools, with spare tire, with LTO plate, scratches on tail light, right side mirror loose, battery weak
