## General Information

| Make | Toyota | Model | Vios |

## Body / Panel Condition

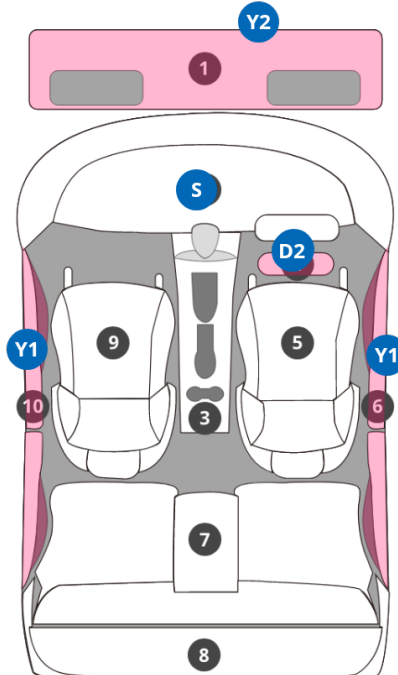
| Interior Evaluation : <b>B</b> | Exterior Evaluation : <b>C</b> |
| <b>Remarks</b><br>Overall Interior - Smell - Yes / Mat Other - Grime - Medium / (L) Front Floor Mat - Worked - Small / (R) Front Trim - Grime - Minimal / (L) Front Trim - Grime - Minimal / Ceiling - Grime - Small | <b>Remarks</b><br>(R) Front Fender, Molding - Scratch - Minimal / (R) Mirror - Scratch - Minimal / (R) Front Door, Molding - Scratch - Small / (R) Rear Door, Molding - Scratch - Small / (R) Rear Fender, Molding - Scratch - Minimal / Rear Bumper, Lamps, Panels - Scratch - Minimal / Trunk Hood, Rear Gate - Scratch - Small / (L) Rear Fender, Molding - Scratch - Small / (L) Front Door, Molding - Scratch - Small / (L) Rear Door, Molding - Scratch - Minimal / (L) Mirror - Scratch - Minimal / (L) Front Fender, Molding - Scratch - Small / Front Bumper, Grille, Lamps - Scratch - Small / Bonnet, Headlight - Scratch - Small / Roof - Scratch - Minimal |

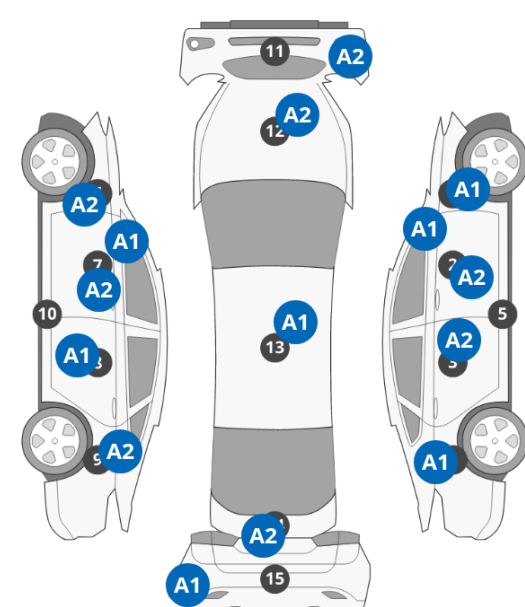
no warranty booklet, no jack and tools, with spare tire, with LTO plate, scratches on tail light, engine won't start, non moving vehicle, functional can't verify due to engine won't start
