## General Information

| Make | Toyota | Model | Lite Ace |
| Registration No. | FAO8824 | Chassis No. | MHKU3FE10PK003803 |

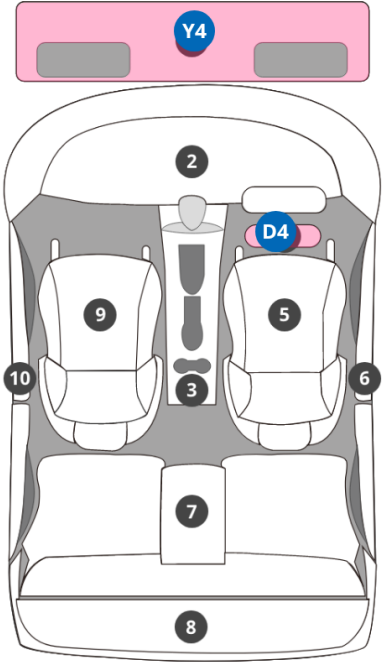
| Interior Evaluation : <span style="color: red;">C</span> | Exterior Evaluation : <span style="color: red;">E</span> |
|---|---|
| <b>Remarks</b><br>Carpet - Worked - Large / Ceiling - Grime - Large | <b>Remarks</b><br>(L) Side Gate - Scratch & Dent - Large / (L) Front Door, Molding - Scratch - Large / Front Bumper, Grille, Lamps - Scratch - Medium / (R) Mirror - Scratch - Small / (R) Front Fender, Molding - Scratch - Small / (R) Front Door, Molding - Scratch - Medium / (R) Side Gate - Scratch - Large / Rear Bumper, Lamps, Panels - Scratch & Dent - Large / Rear Gate - Scratch - Small / Roof - Scratch & Dent - Small |
