## General Information

| Make | Toyota | Model | Vios |
| Registration No. | FAP6732 | Chassis No. | PA1B18F38P4222573 |

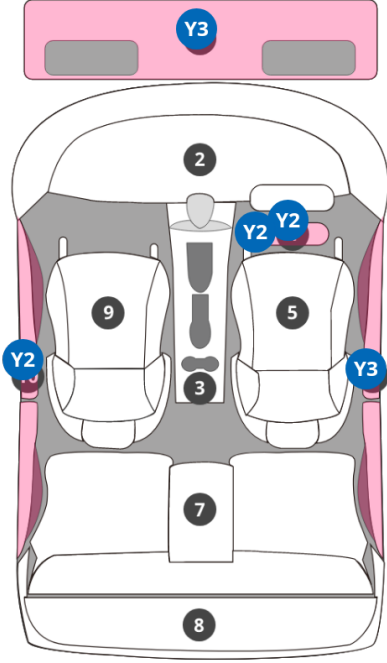
| Interior Evaluation : <b>B</b> | Exterior Evaluation : <b>B</b> |
|---|---|
| <p><b>Remarks</b><br/>Ceiling - Grime - Medium / (R) Front Trim - Grime - Medium / (L) Front Trim - Grime - Small / Mat Other - Grime - Small / (L) Front Floor Mat - Grime - Small</p> | <p><b>Remarks</b><br/>(R) Front Door, Molding - Scratch - Small / (R) Rear Fender, Molding - Scratch - Small / (R) Rear Door, Molding - Scratch &amp; Dent - Minimal / Rear Bumper, Lamps, Panels - Scratch &amp; Dent - Medium / (L) Mirror - Scratch - Minimal / Front Bumper, Grille, Lamps - Scratch - Small</p> |
