General Information

Make	Toyota	Model	Vios
YOM	2023	Odo Meter Reading	32,633
Registration No.	FAP7632	Chassis No.	PA1B18F3XP4222624
CC	1.3	Transmission	CVT
Fuel Type	Gas	Type of Body	Sedan
Colour	Green

Body / Panel Condition

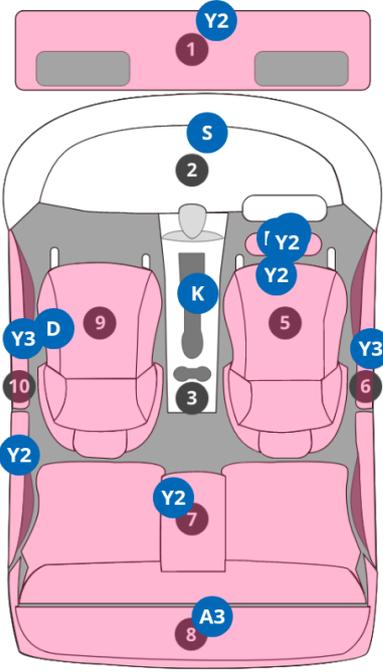
Interior Evaluation : C	Exterior Evaluation : E

<p>a : Cut, Fray d : Loose, Deformed k : Animal Hair s : Smell t : Cigarette Burns x : Defective y : Stain</p>

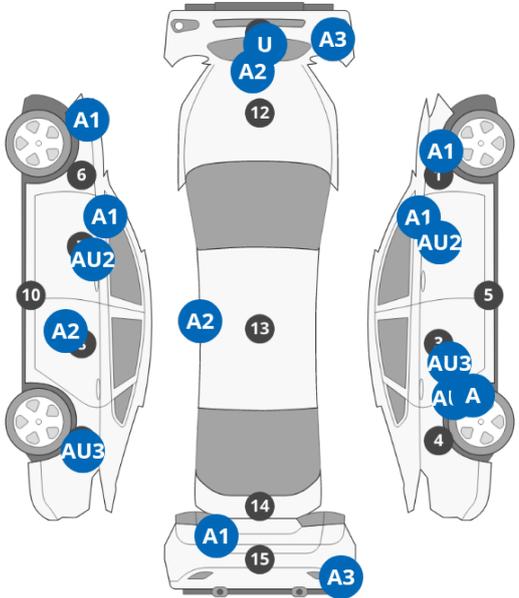
<p>A : Scratch AU : Scratch & Dent B : Modified C : Corrosion G : Stone chip P : Faded S : Rust SC : Rust & Corrosion U : Dent X : Defective Y : Crack, Gap</p>
<p>Remarks (L) Front Floor Mat - Worked - Small / (R) Front Floor Mat - Grime - Small / Mat Other - Grime - Small / Rear Seat - Grime - Small / (L) Front Seat - Worn - Yes / Overall Interior - Smell - Yes / Overall Interior - Worn as per age - Yes / Ceiling - Grime - Small / (L) Rear Trim - Grime - Small / (R) Front Trim - Grime - Medium / (R) Front Seat - Grime - Small / (L) Front Trim - Grime - Medium / Trunk Room - Worn, Scratch, Cut, Crack - Medium / Overall Interior - Animal Hair - Yes</p>	<p>Remarks (R) Front Fender, Molding - Scratch - Minimal / (R) Mirror - Scratch - Minimal / (R) Front Door, Molding - Scratch & Dent - Small / (R) Rear Door, Molding - Scratch & Dent - Medium / (R) Rear Fender, Molding - Scratch & Dent - Small / (R) Rear Tyre - Crack, Cut - Yes / Rear Bumper, Lamps, Panels - Scratch - Medium / (L) Rear Fender, Molding - Scratch & Dent - Medium / Trunk Hood, Rear Gate - Scratch - Minimal / (L) Rear Door, Molding - Scratch - Small / (L) Mirror - Scratch - Minimal / Member (Bolted) - Dent - Yes / (L) Front Fender, Molding - Scratch - Minimal / Front Bumper, Grille, Lamps - Scratch - Medium / Bonnet, Headlight - Scratch - Small / Roof - Scratch - Small / (L) Front Door, Molding - Scratch & Dent - Small</p>
