## General Information

| Make | Toyota | Model | Vios |

## Body / Panel Condition

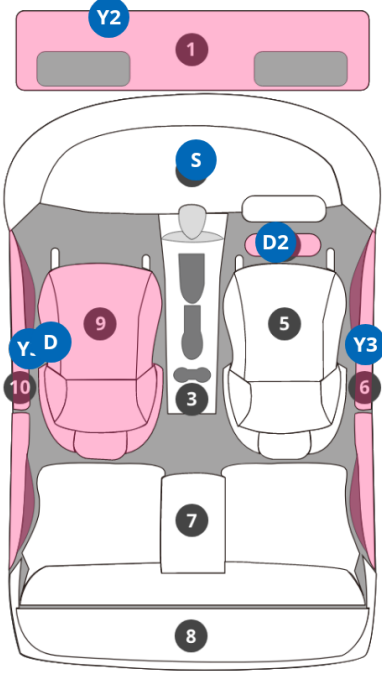
| Interior Evaluation : <b>B</b> | Exterior Evaluation : <b>C</b> |
| <p><b>Remarks</b><br/>(L) Front Floor Mat - Worked - Small / (L) Front Trim - Grime - Medium / (R) Front Trim - Grime - Medium / Overall Interior - Smell - Yes / (L) Front Seat - Worn - Yes / Ceiling - Grime - Small</p> | <p><b>Remarks</b><br/>Member (Bolted) - Dent - Yes / (R) Front Fender, Molding - Scratch - Minimal / (R) Mirror - Scratch - Minimal / (R) Front Door, Molding - Scratch - Small / (R) Rear Door, Molding - Scratch - Small / (R) Rear Fender, Molding - Scratch - Minimal / Rear Bumper, Lamps, Panels - Scratch - Small / (L) Rear Fender, Molding - Scratch - Minimal / (L) Front Door, Molding - Scratch &amp; Dent - Small / (L) Rear Door, Molding - Dent - Small / (L) Mirror - Scratch - Minimal / (L) Front Fender, Molding - Scratch - Minimal / Front Bumper, Grille, Lamps - Scratch &amp; Dent - Medium / Bonnet, Headlight - Scratch - Small / Roof - Dent - Small / Trunk Hood, Rear Gate - Scratch - Small</p> |
