## General Information

| Make | Toyota | Model | Vios |
| YOM | 2024 | Odo Meter Reading | 18,198 |
| Registration No. | FAQ3001 | Chassis No. | PA1B18F34P4230024 |

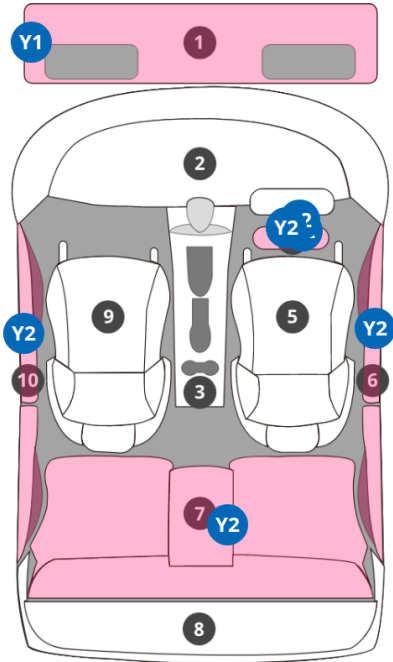
| Interior Evaluation : <b>B</b> | Exterior Evaluation : <b>C</b> |
| <b>Remarks</b><br>Rear Seat - Grime - Small / (L) Front Trim - Grime - Small / (R) Front Trim - Grime - Small / (L) Front Floor Mat - Worked - Small / (R) Front Floor Mat - Grime - Small / Mat Other - Grime - Small / Ceiling - Grime - Minimal | <b>Remarks</b><br>(R) Front Door, Molding - Scratch - Small / (R) Front Fender, Molding - Scratch - Minimal / (R) Mirror - Scratch - Minimal / (R) Rear Door, Molding - Scratch - Small / (R) Rear Fender, Molding - Scratch - Medium / Rear Bumper, Lamps, Panels - Scratch & Dent - Medium / Trunk Hood, Rear Gate - Scratch & Dent - Small / (L) Rear Fender, Molding - Scratch - Minimal / (L) Step, In-panel, Side Spoiler - Scratch & Dent - Medium / (L) Rear Door, Molding - Scratch - Minimal / (L) Front Door, Molding - Scratch - Small / (L) Mirror - Scratch - Minimal / (L) Front Fender, Molding - Scratch - Minimal / Front Bumper, Grille, Lamps - Scratch - Medium / Bonnet, Headlight - Scratch - Minimal / Roof - Scratch - Minimal |

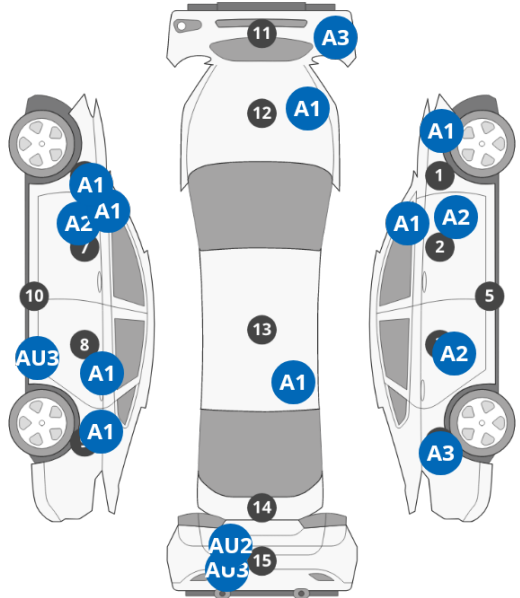
| Inspector Notes |
|---|
| with warranty booklet, no jack and tools, with spare tire, no LTO plate, scratches on tail light |
