## General Information

| Make | Toyota | Model | Vios |
| Registration No. | FAQ3576 | Chassis No. | PA1B18F32P4233018 |

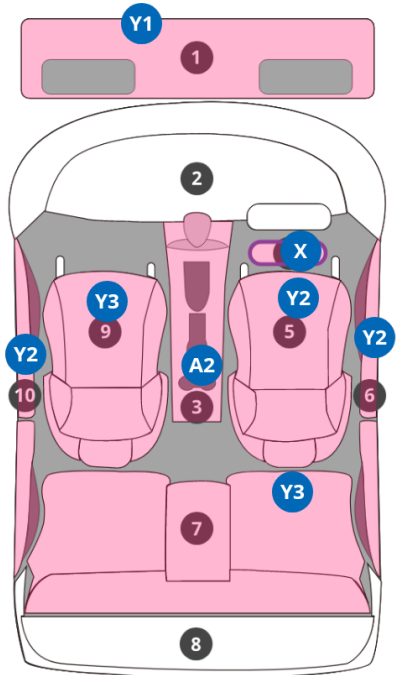
| Interior Evaluation : <b>B</b> | Exterior Evaluation : <b>B</b> |
| <p><b>Remarks</b></p> <p>(L) Front Floor Mat - Missing - Yes / (L) Front Seat - Grime - Medium / (R) Front Seat - Grime - Small / (R) Front Trim - Grime - Small / (L) Front Trim - Grime - Small / Ceiling - Grime - Minimal / Console, Switches, Vents - Worn, Scratch, Cut, Crack - Small / Rear Seat - Grime - Medium</p> | <p><b>Remarks</b></p> <p>(R) Mirror - Scratch - Minimal / (R) Front Fender, Molding - Scratch - Minimal / (R) Front Door, Molding - Scratch - Minimal / (R) Rear Door, Molding - Scratch - Small / (R) Rear Fender, Molding - Scratch - Minimal / Rear Bumper, Lamps, Panels - Scratch - Small / Trunk Hood, Rear Gate - Scratch - Minimal / (L) Front Door, Molding - Scratch - Small / (L) Rear Door, Molding - Scratch - Minimal / (L) Mirror - Scratch - Minimal / (L) Front Fender, Molding - Scratch - Minimal / Front Bumper, Grille, Lamps - Scratch - Minimal / Bonnet, Headlight - Scratch - Minimal / Roof - Dent - Minimal / (L) Rear Fender, Molding - Scratch - Minimal</p> |
