General Information

Make	Toyota	Model	Vios
YOM	2024	Odo Meter Reading	23,311
Registration No.	FAQ4805	Chassis No.	PA1B18F37P4233421
CC	1.3	Transmission	CVT
Fuel Type	Gas	Type of Body	Sedan
Colour	Silver

Body / Panel Condition

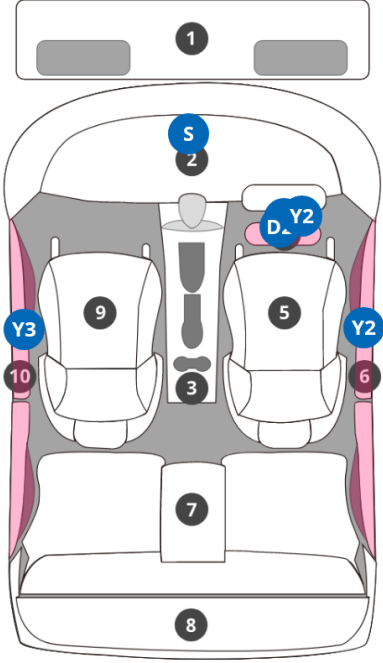
Interior Evaluation : B	Exterior Evaluation : D

<p>a : Cut, Fray d : Loose, Deformed k : Animal Hair s : Smell t : Cigarette Burns x : Defective y : Stain</p>

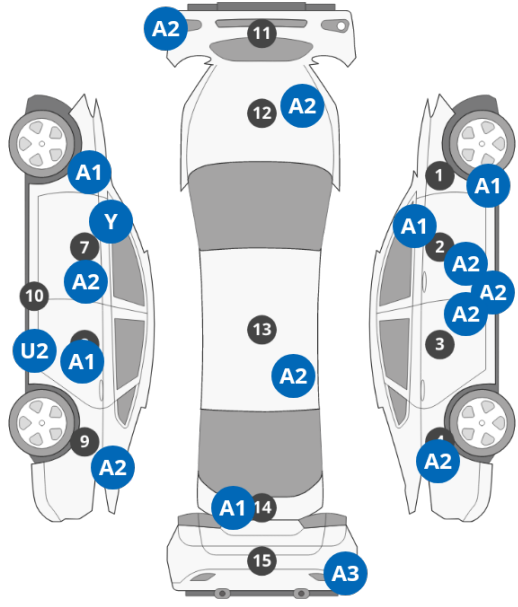
<p>A : Scratch AU : Scratch & Dent B : Modified C : Corrosion G : Stone chip P : Faded S : Rust SC : Rust & Corrosion U : Dent X : Defective Y : Crack, Gap</p>
<p>Remarks Mat Other - Cut, Crack - Medium / (L) Front Floor Mat - Worked - Small / (R) Front Trim - Grime - Small / (L) Front Trim - Grime - Medium / (R) Front Floor Mat - Grime - Small / Overall Interior - Smell - Yes</p>	<p>Remarks (L) Rear Fender - Repair Traces - Yes / (R) Front Fender, Molding - Scratch - Minimal / (R) Front Door, Molding - Scratch - Small / (R) Step, In-panel, Side Spoiler - Scratch - Small / (R) Rear Door, Molding - Scratch - Small / (R) Rear Fender, Molding - Scratch - Small / Rear Bumper, Lamps, Panels - Scratch - Medium / Trunk Hood, Rear Gate - Scratch - Minimal / (L) Front Door, Molding - Scratch - Small / (L) Rear Door, Molding - Scratch - Minimal / (L) Step, In-panel, Side Spoiler - Dent - Small / (L) Mirror - Crack - Damaged / (L) Front Fender, Molding - Scratch - Minimal / Front Bumper, Grille, Lamps - Scratch - Small / Bonnet, Headlight - Scratch - Small / (L) Rear Fender, Molding - Scratch - Small / (R) Mirror - Scratch - Minimal / Roof - Scratch - Small</p>
