General Information

Make	Toyota	Model	Vios
YOM	2024	Odo Meter Reading	21,430
Registration No.	FAQ5689	Chassis No.	PA1B18F35P4232929
CC	1.3	Transmission	CVT
Fuel Type	Gas	Type of Body	Sedan
Colour	Green

Body / Panel Condition

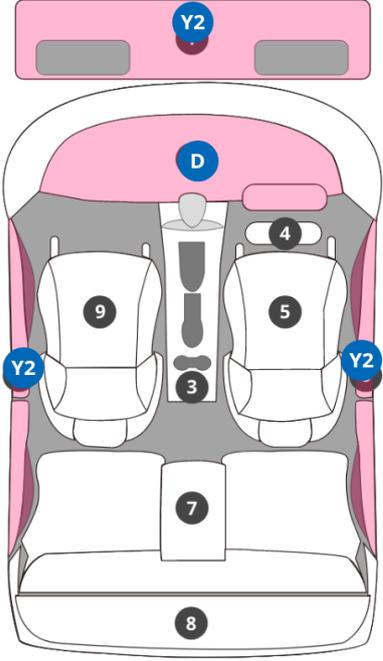
<p>a : Cut, Fray d : Loose, Deformed k : Animal Hair s : Smell t : Cigarette Burns x : Defective y : Stain</p>

<p>A : Scratch AU : Scratch & Dent B : Modified C : Corrosion G : Stone chip P : Faded S : Rust SC : Rust & Corrosion U : Dent X : Defective Y : Crack, Gap</p>
Remarks Ceiling - Grime - Small / (R) Front Trim - Grime - Small / (L) Front Trim - Grime - Small / Dashboard - Traces of Adhesive Tape - Yes	Remarks Front Bumper, Grille, Lamps - Scratch & Dent - Medium / Bonnet, Headlight - Scratch - Small / (R) Mirror - Scratch - Small / (R) Front Fender, Molding - Scratch - Minimal / (R) Front Door, Molding - Scratch - Minimal / (R) Rear Door, Molding - Scratch - Minimal / Rear Bumper, Lamps, Panels - Scratch - Small / (L) Step, In-panel, Side Spoiler - Scratch - Minimal / (L) Mirror - Scratch - Minimal
Frame Evaluation : A	Functional Evaluation : C
