## General Information

| Make | Toyota | Model | Vios |

## Body / Panel Condition

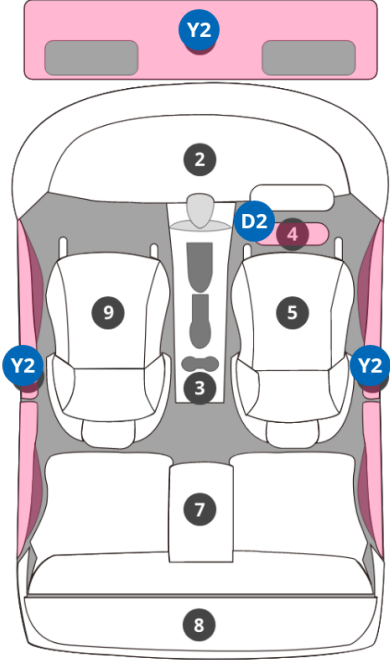
| Interior Evaluation : <b>A</b> | Exterior Evaluation : <b>B</b> |
|---|---|
| <p><b>Remarks</b><br/>Ceiling - Grime - Small / (R) Front Trim - Grime - Small / (L) Front Trim - Grime - Small / (L) Front Floor Mat - Worked - Small</p> | <p><b>Remarks</b><br/>(L) Front Door, Molding - Scratch - Small / (L) Front Fender, Molding - Scratch - Minimal / Front Bumper, Grille, Lamps - Scratch - Minimal / (R) Front Fender, Molding - Scratch - Minimal / (R) Mirror - Scratch - Minimal / Rear Bumper, Lamps, Panels - Scratch - Small / (L) Step, In-panel, Side Spoiler - Scratch - Small / Trunk Hood, Rear Gate - Scratch - Minimal</p> |
