General Information

Make	Toyota	Model	Vios
YOM	2024	Odo Meter Reading	20,862
Registration No.	FAR1597	Chassis No.	PA1B18F38P4234125
CC	1.3	Transmission	CVT
Fuel Type	Gas	Type of Body	Sedan
Colour	Blue

Body / Panel Condition

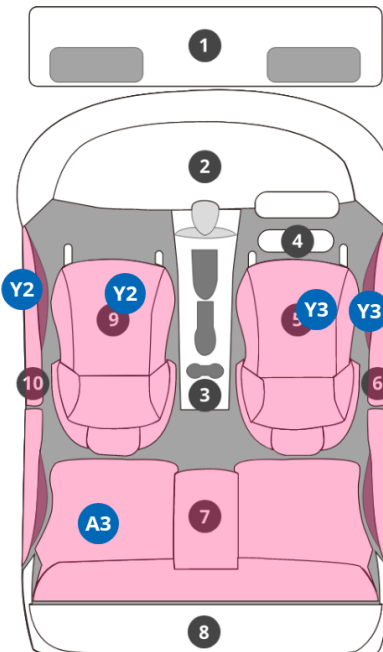
Interior Evaluation : B	Exterior Evaluation : C

<p>a : Cut, Fray d : Loose, Deformed k : Animal Hair s : Smell t : Cigarette Burns x : Defective y : Stain</p>

<p>A : Scratch AU : Scratch & Dent B : Modified C : Corrosion G : Stone chip P : Faded S : Rust SC : Rust & Corrosion U : Dent X : Defective Y : Crack, Gap</p>
<p>Remarks Rear Seat - Cut, Crack - Medium / (R) Front Trim - Grime - Medium / (R) Front Seat - Grime - Medium / (L) Front Trim - Grime - Small / (L) Front Seat - Grime - Small</p>	<p>Remarks Trunk Hood, Rear Gate - Repair Traces - Yes / (R) Front Door, Molding - Scratch & Dent - Large / (R) Rear Door, Molding - Scratch & Dent - Small / Rear Bumper, Lamps, Panels - Scratch - Minimal / Trunk Hood, Rear Gate - Dent - Small / (L) Rear Door, Molding - Scratch - Small / (L) Front Door, Molding - Scratch - Small / (L) Front Fender, Molding - Scratch & Dent - Medium / (R) Front Fender, Molding - Scratch - Minimal / Bonnet, Headlight - Scratch - Small / Front Bumper, Grille, Lamps - Scratch - Minimal / (R) Rear Fender, Molding - Scratch - Minimal</p>
